# Proposal for rehabilitation of the Upper Peatland Basin

Frederik Jansen and Jelle van Veen

Land and Water management

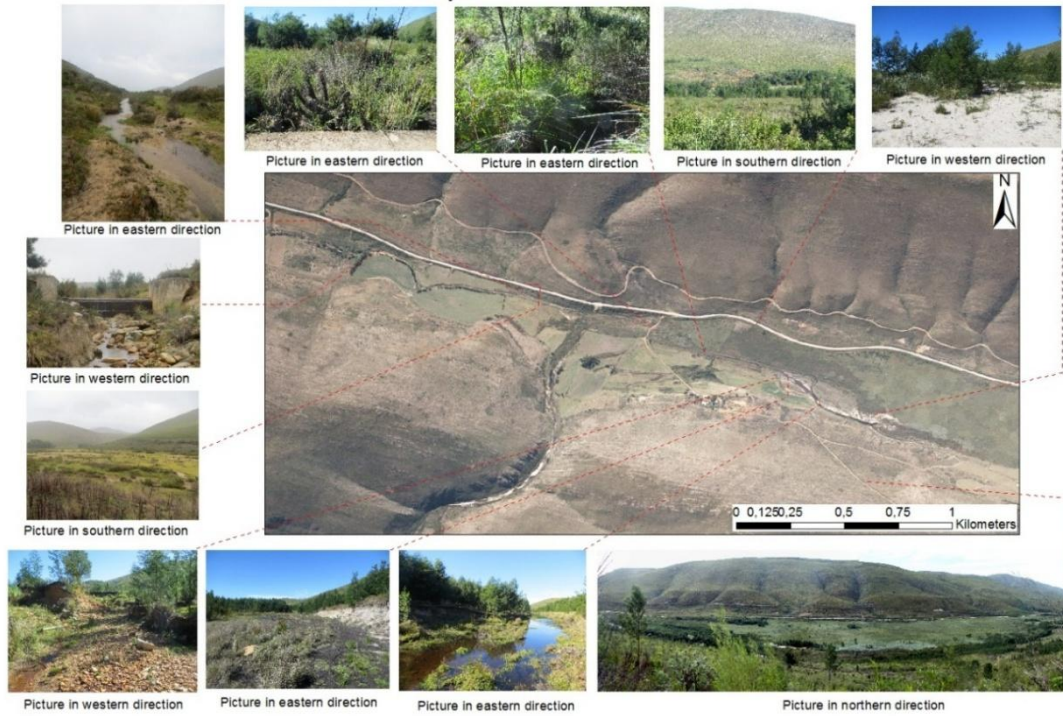
Figure 2: Western part of the wetland in current state  
Source: Author's work

In this chapter, the project area is introduced by discussing multiple aspects of the area. In the first paragraph, the location of the project area and the location of the Upper Peatland Basin are shown. The Upper Peatland Basin is the wetland itself. This wetland is located in a larger area of floodplain, defined as the project area. Other aspects in this chapter are different types of land use, geology, hydrology, water quality, flora and fauna, and the history of the project area. The two maps shown below are made to get a clear view of the project area. Pictures of the project area are presented around the map and the location of the pictures are indicated with the red dotted lines. **View of the western part of the wetland in current state**

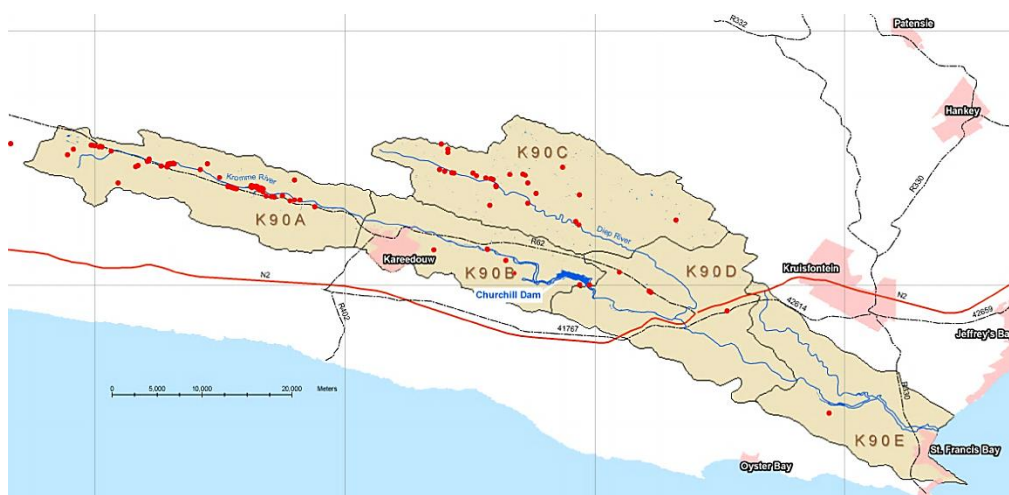
Figure 4: Kromme River Catchments

The two dams in the Kromme River are the Churchill Dam and the Impofu Dam. The Churchill Dam is established in 1943, and provides 40% of Port Elizabeth’s water. The mentioned dam is the southern border of the Upper Kromme Catchment. (Department of Environmental affairs, 2013)As can be noticed in figure 4 the whole Kromme River Catchment is divided in five sub catchments. Together, he sub catchments K90A and K90B are called the Upper Kromme Catchment. The Impofu Dam is located downstream of the Churchill Dam, on the western border of sub catchment K90B.

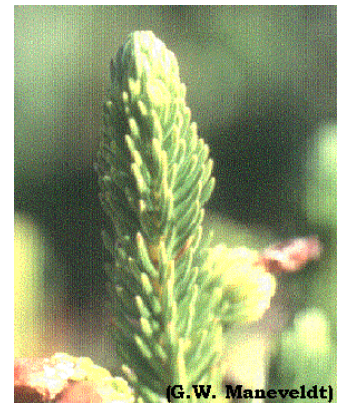
Figure 11: Ericoid Leaves  
source: (Maneveldt, sd)

Fynbos plants are recognized by the small, hard, tough and leathery leaves (ericoid leaves, figure 12). Fynbos contains members of seven plant families found nowhere else in the world. Over 7700 plant species are found in fynbos, from which 69 percent are endemic to the area. This means, 69% of the plants in fynbos can be found nowhere else in the world. (Maneveldt, sd)

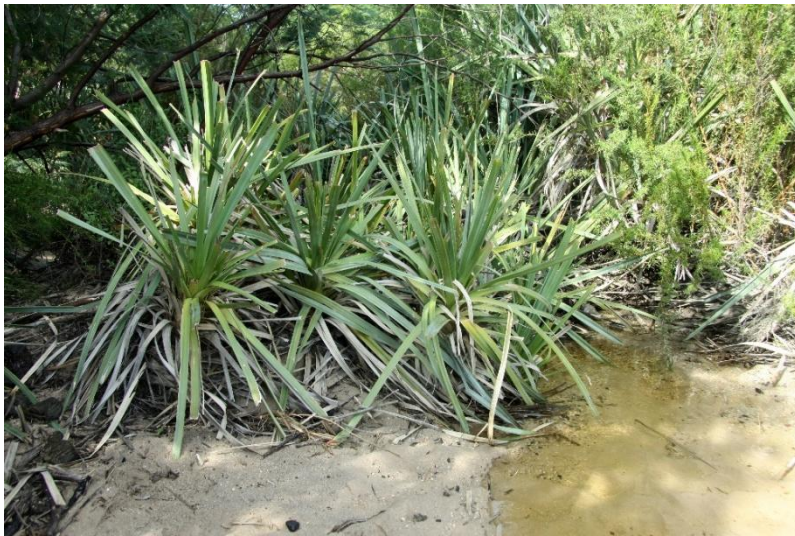
Figure 13 : Palmiet  
Source: author's work

Wet conditions, nutrient poor soil and an open environment to catch enough sunlight are necessary for conservation and growth of this species.

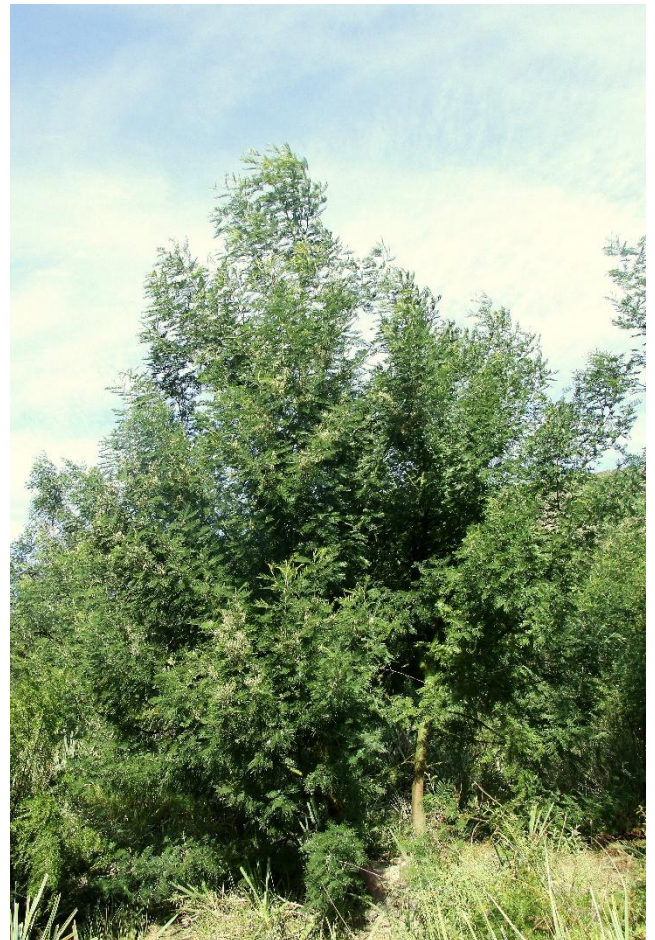
Figure 14: Black Wattle  
source: Author's work

The Black Wattle tree is an invader from South-eastern Australia and Tasmania, and is now a problem in the Western Cape, the Eastern Cape, Kwa-Zulu Natal, Mpumalanga and Gauteng. (Invasives, sd). As to be seen in figure 11, Black Wattle is scattered all over the area, including the wetlands.

The Black Wattle is an evergreen tree which grows up to ten meter high. The leaves are dark olive-green with finely haired pods. (Invasives, sd) The roots of the Black Wattle are sparse.

Because of the roots, this tree is not able to keep the soil together as good as Palmiet during floods. Furthermore, this tree replaces the original and natural species. (Invasives, sd). The governmental program Working for Water wants to get rid of this alien by cutting it down. (Personal comment Japie Buckle, May 22<sup>nd</sup>, 2014)

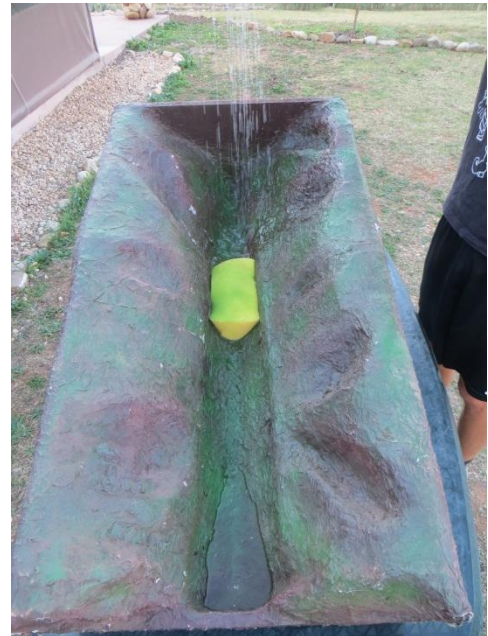
Figure 15: A simple model of a wetland  
Source: Author's work

Storage of water in the thick peat beds causes a more constant river flow. Palmiet builds up very fine peat, with an accumulation rate of 0,3 to 0,7 mm depth a year. Every cubic meter soil of which 70% is carbon peat can store 700 liters of water. (Personal comment Japie Buckle, May 22<sup>nd</sup>, 2014) The peatland works as a natural sponge, by storing rainwater and releasing it steadily over time. (Czeglédi, 2013) After approximately four dry years in the Upper Peatland Basin, three heavy rain events were needed to make a little bit of water flowing out of the wetland. (Personal comment Japie Buckle, May 22<sup>nd</sup>, 2014) The great water storage capacity of peat is a very important result of a Palmiet wetland. Because of this capability, the river downstream is less likely to overflow. The wave of water from a heavy rainfall will be longer but flatter. In the situation of the Upper Peatland Basin, this will make the Churchill dam less likely to overflow, which will save a lot of fresh water. Therefore, it is very important to maintain Palmiet in order to maintain wetlands.

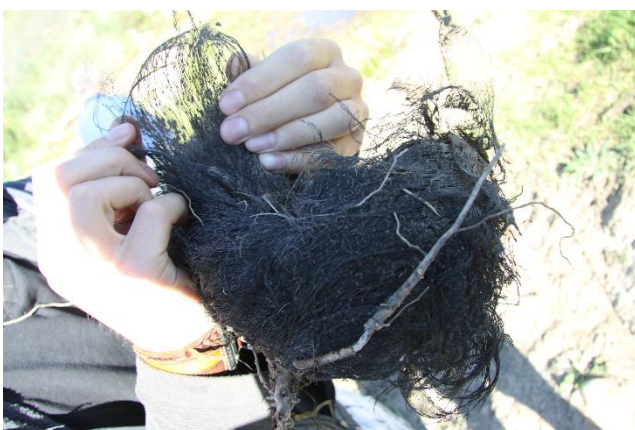
Figure 16: Roots Palmiet  
Source: Author's work

All the wetlands in the Kromme are very important for protecting the dams against sedimentation and flooding. Wetlands, like the Upper Peatland Basin, are natural buffers against flood damage. In fact, they are the “glue” that keeps the soil together and prevents erosion processes. Figure 18 and figure 19 show why Palmiet is very capable in keeping the soil together. Figure 18 shows the roots of Palmiet, figure 19 shows a leaf of Palmiet. Because of this dense structure of the Palmiet, they are adapted to break the floods. They slow down the runoff, which provides time for infiltration. On the next page, figure 20 shows the hydrologic buffering effect of the wetlands on the high river flow peaks. (Mr. Japie Buckle et al. undated)

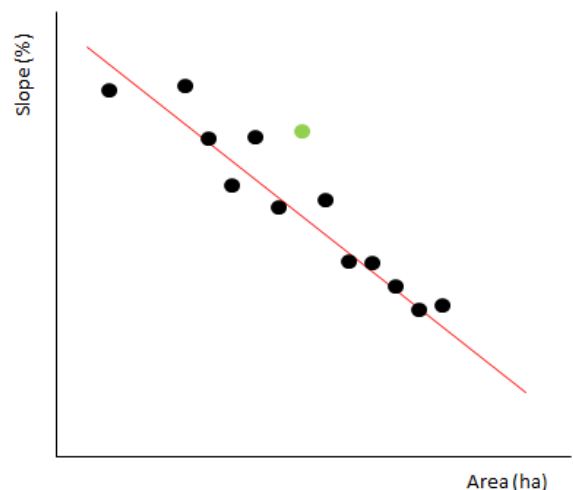
Figure 19: Correlation slope/area wetland  
 Source: Personal comment Fred Ellery, author's work

Moreover, this plant can grow in areas with a gradient up to three percent, which is extraordinary for wetland plants. Figure 14 presents the correlation between the slope in a particular area and the area of the wetland. The gradient of an area is negative correlated to the area of wetland. The steeper the slope, the smaller the area of the wetland. Dots above the red line are areas in which gullies and other erosion processes occur. In this case the wetland cannot handle the high water energy generated by the steep slope. One exception to this negative relationship are the Palmiet wetlands, shown as the green dot in the graph. Those specific wetlands are able to counter erosion processes due to

Palmiet vegetation, while other wetlands without Palmiet but with the same slope gradient have been eroded already. This feature makes Palmiet-dominated wetlands unique in the world. (Personal comment Fred Ellery, June 19<sup>th</sup>, 2014)

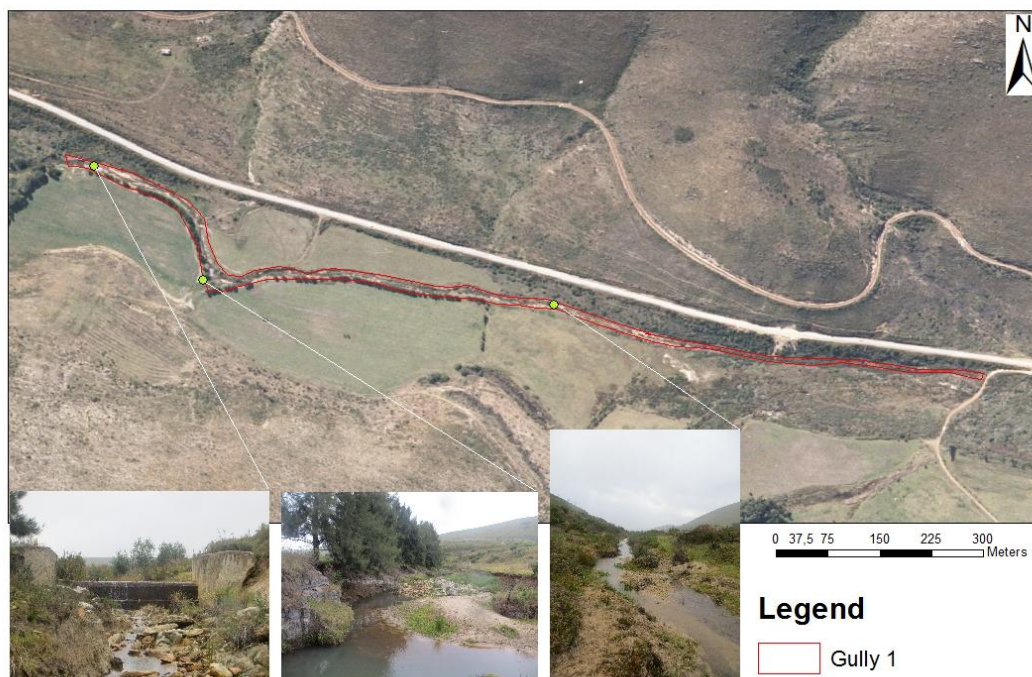
Figure 23: Location Gully 1  
Source: Author's work

Gully 1 is located in the most western part of the wetland. Figure 24 presents the exact location and some pictures from the gully. The gully is surrounded by pastures, but close to the main- and back road by bushes and bulrushes. In 1942 this area was still part of the wetland in terms of vegetation, soil and hydrology. A big flood and agricultural practices more upstream are probably causes for the channel marked as gully 1. Later on, Black Wattle began to overtake the wetland vegetation. When they cut down the Black Wattle, the area became suitable for orchards and pastures. (Personal comment farmer Pierre Oelofsen, June 19th 2014) In the last approximately 70 years, the original Palmiet dominated wetland totally disappeared in this area and changed to farmland with drains and gullies. The gully was lengthening upstream until the moment a structure was built to stop the headcut from moving. (A headcut is the sudden change in elevation or knick point at the leading edge of a gully. (Agricultural Research Service, 2013) Too much water energy at this certain point starts erosion and makes the headcut move upstream. Then the gully will expand, resulting in damage over an increasing area.) The concrete structure that is built to stop the headcut of gully 1 is marked with a purple outline in figure 25.

Despite the fact that the headcut of gully 1 stopped moving, this western area of the wetland still does not work as a healthy wetland, like it once did. Transforming this area back to a Palmiet dominated wetland might be realized by building another hydraulic structure in the flood plain. A hydraulic structure should rise the water table and force the water to flow over the whole flood plain instead of only flowing in the current channels. The green circle in figure 25 shows a potential suitable location for a structure. Water from the tributary and the Kromme itself should be dammed when a structure is placed in the green circle. The water level will rise and could create new appropriate conditions for wetland vegetation. Furthermore, the structure traps sediment, which will slowly fill up gully 1. Lack of bed rock as solid foundation is the reason a flexible structure instead of a concrete structure will be the most proper solution to realize a new wetland environment in this area.

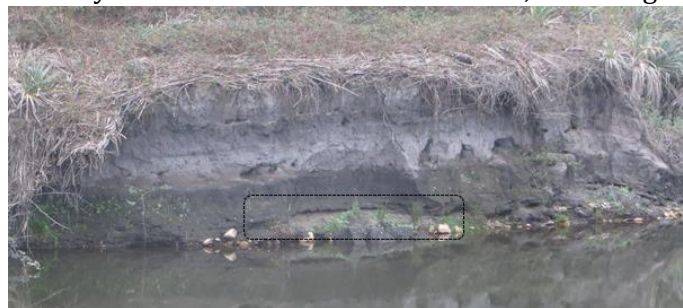
Figure 26: Piping  
Source: Author's work

Especially when the structure is built on vulnerable layers as for instance sand layers, the risk of piping is high. To prevent this from happening, a mattress with geo textile could be placed just upstream from the gabion. To remove

the massive amount of hydrostatic pressure, pipelines are usually used to let water flow from the one side of the gabion to the other. A gabion structure including these pipelines is presented in figure 28. The black outline in figure 28 shows water coming out of a pipeline and reach the surface as result of the hydrostatic pressure.

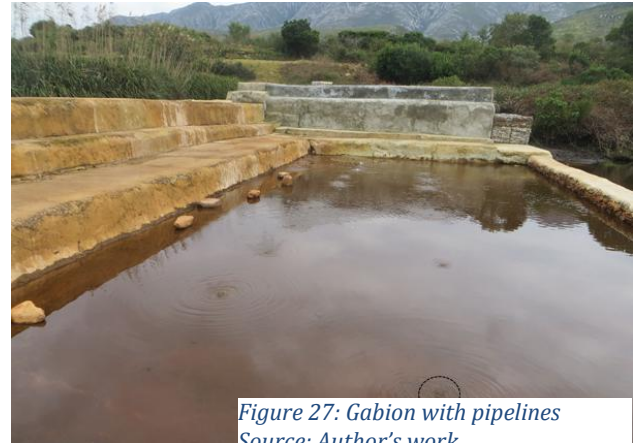
Figure 27: Gabion with pipelines  
Source: Author's work

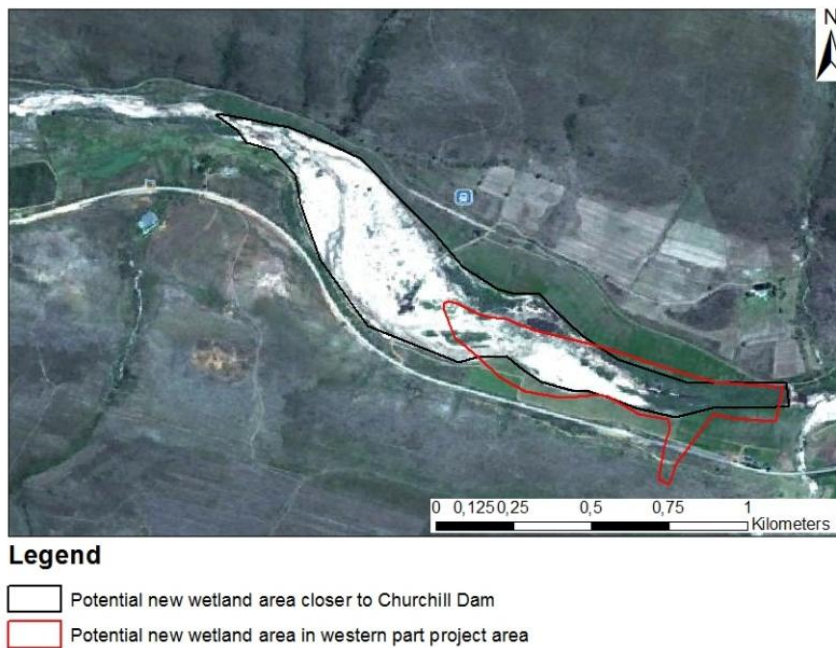
Figure 38: Potential new wetland areas as result of a gabion  
Source: Author's work

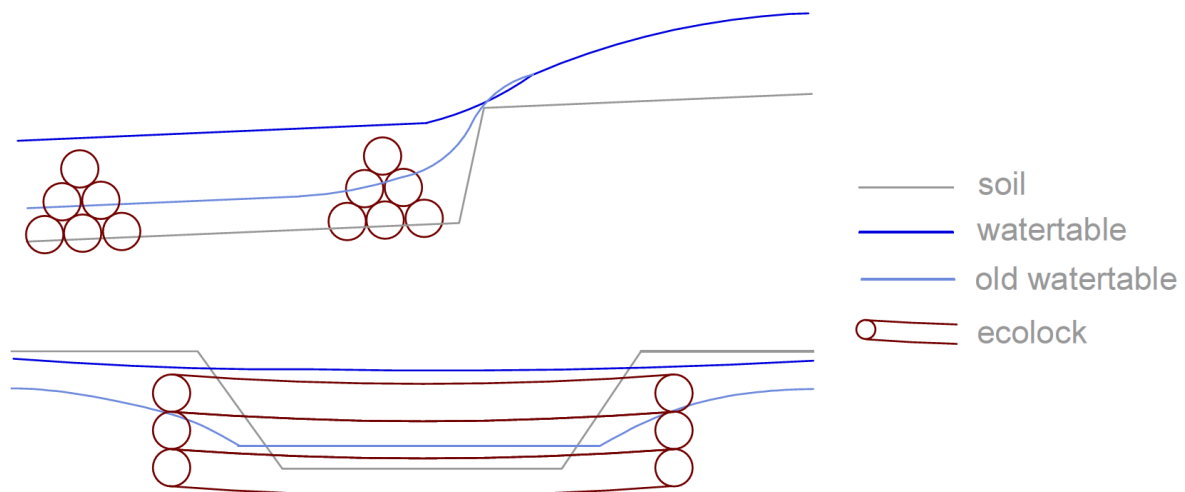
Figure 34: Ecolocks  
Source: Author's work

By removing the berms and blocking the drains, the area becomes flatter and water will flow in a braided pattern instead of flow through the drains. The water table should rise, and erosion processes should be countered because of the dispersed water energy. Wetland plants get provided with better environmental conditions and start to take over. A good, cheap way to block drains is by placing ecolocks in the drain. Ecolocks are flexible tubes, wrapped with geotextile and filled with sand. Three of those tubes will be placed at the bottom of the drain, two will be placed upon them and one on top of them. To make this solution effective, an ecolock should be placed every 25-50 meters. See figure 35 for a cross section of ecolocks.

The short distance between the ecolocks prevents headcuts from further erosion. The soil that is extracted by removing berms can be used to fill the ecolocks. The rest of the soil can be used to fill the drains and gullies in the wetland. This is a low-cost, sustainable solution to transfer the wetland from a rough, drained, bubbly area to a smooth one.

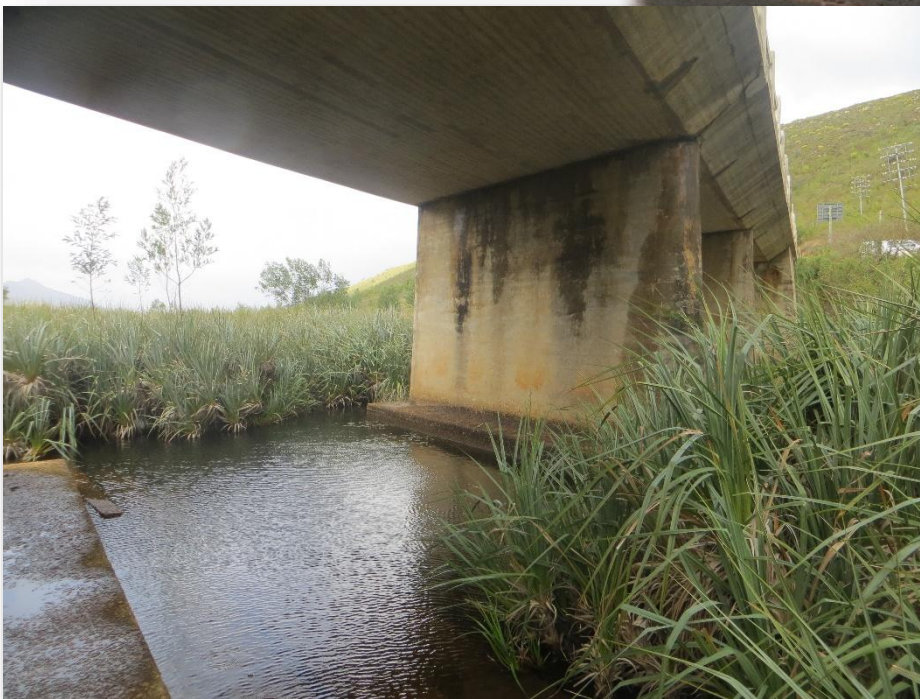
*Figure 36: Bridge R62*  
*Source: Author's work*

Another option to expand the wetland near the bridge is by placing culverts below the road, so the water can pass the road in multiple streams, instead of only in one stream below the bridge. However, this can cause the foundation of the road to get weaker, which makes the road more vulnerable to crack. To calculate the possibilities of this solution, to build it, and to maintain it is expensive. Thus, the piece of degraded wetland due to the bridge shall remain degraded, because it is very expensive to restore this small area.

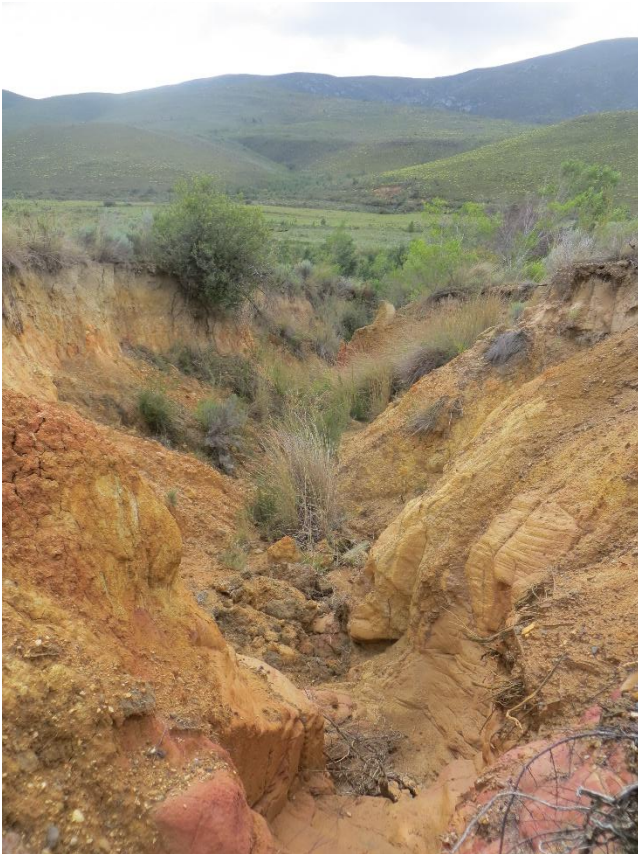
*Figure 37: Tributary on the slope*  
*Source: Authors work*

The rainwater from the surrounding mountains flows down into the Kromme River and the Upper Peatland Basin. The steep slopes of the mountains combined with heavy rainfall create a high energy system, which causes erosion. For that, it is expected that the tributaries are heavily eroded when flowing into the wetland. However, the alluvial fans reduced the steepness of the slope by sedimentation, so there is barely any erosion caused by tributaries next to the wetland. This is a natural process, and neither the erosion on the slope nor the sedimentation at the alluvial fans are a threat for the wetland. Figure 38 and figure 39 show the difference between tributaries with a high slope on the hill, and tributaries next to the wetland. Picture 38 is taken next to the R62 and picture second is taken at the border of the wetland.

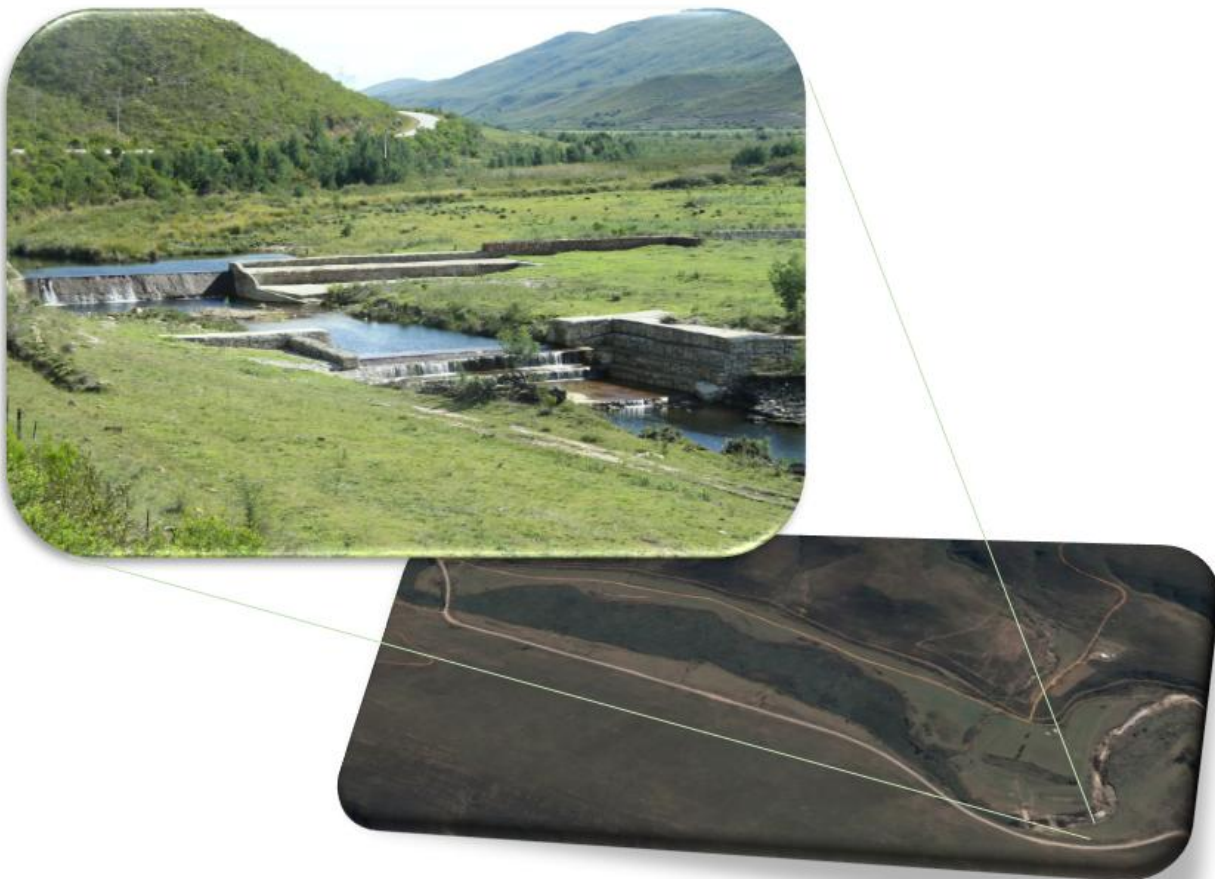
Figure 39: Gabion eastern border Upper Peatland Basin  
Source: Author's work

At the moment, the three structures are performing very well. To counter the erosion process at the eastern site, a gabion is built. Unfortunately, the water flowed around and underneath this structure. Therefore, the structure was partly destroyed and it did not counter the erosion process anymore. As a reaction to the failure of this gabion, a concrete structure is built just upstream from the gabion. The gabion and the concrete structure are both shown in picture 40. The concrete structure took away the high energy of the water, and the two structures combined work perfectly now. There is no headcut upstream from the structures anymore, and the border of the wetland is now exactly where the structures were built. (Personal comment Japie Buckle, May 22<sup>nd</sup>, 2014) However, it can be concluded that hydrolic structures do not always directly work out the way they should.

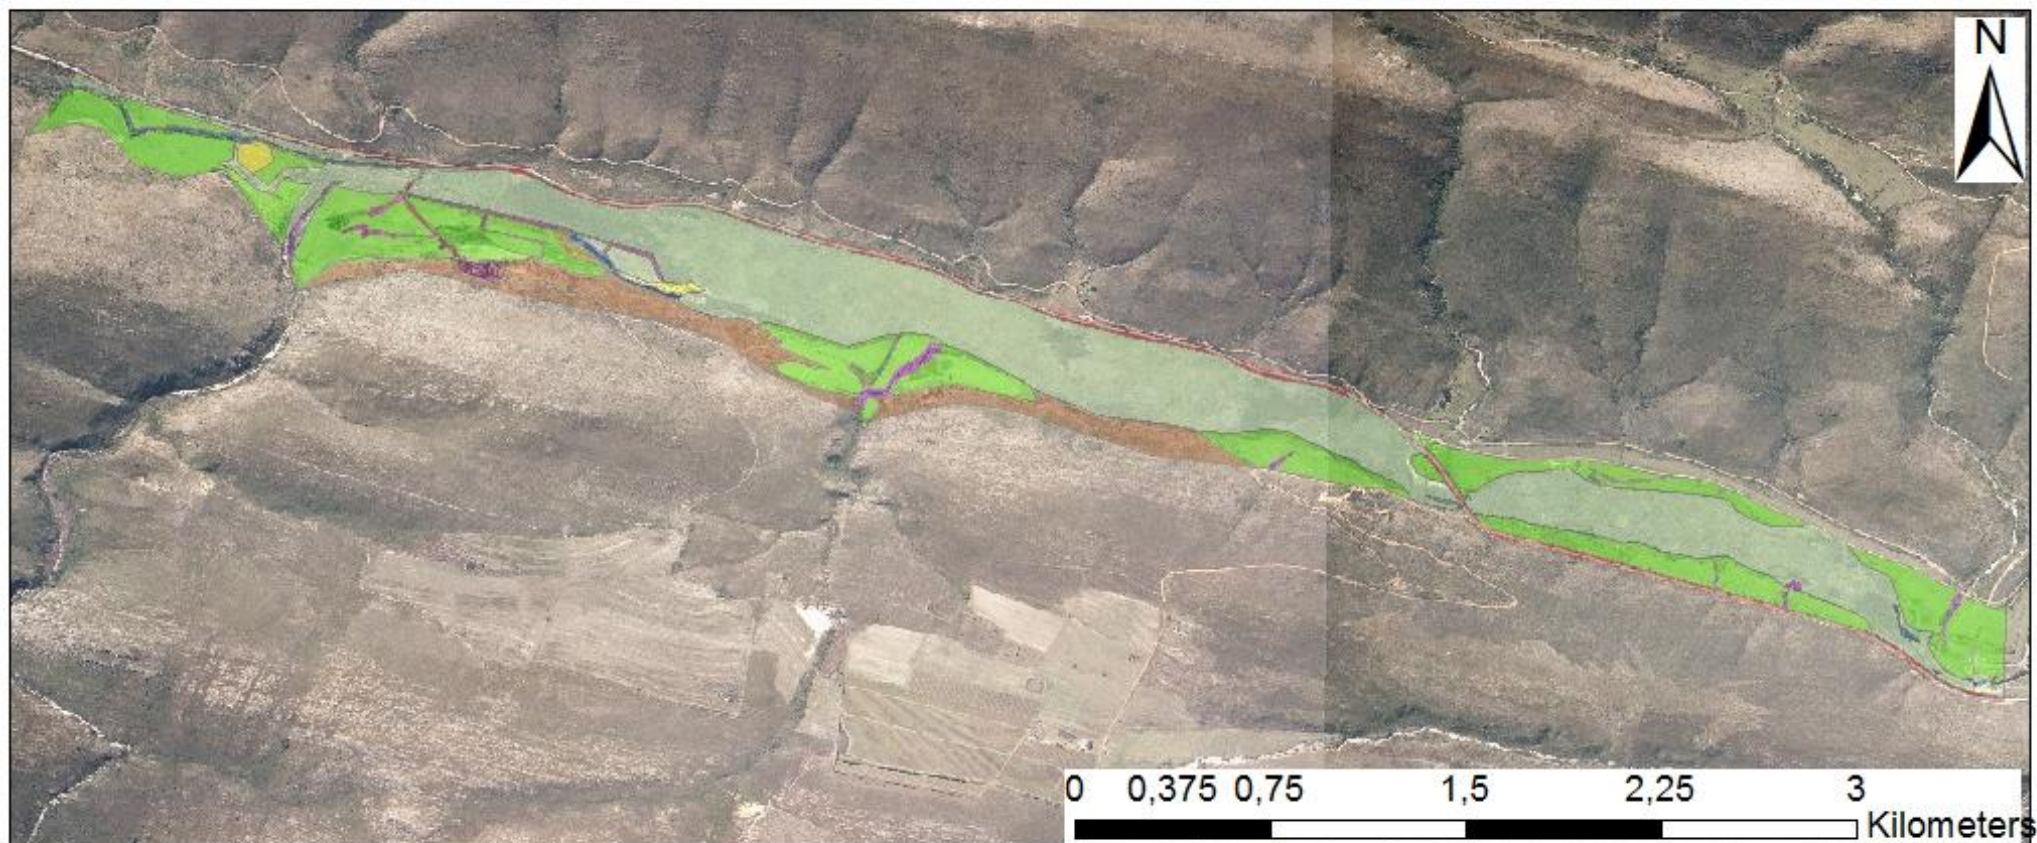
# Current land use project area

Figure 6 shows the current land use in the project area. The Upper Kromme River Catchment is mainly covered with fynbos. On the slopes a dry variant of fynbos is found, while the wetland is home to the fynbos species Palmiet. Besides palmiet, alien vegetation and other wetland vegetation like reeds and other bulrushes are found. The surroundings of the wetland are pastures used for big livestock. To make this wetland useful for agricultural practices as well as pastures, a few man-made drains are dug. Furthermore, places for water storage are dug to irrigate the area. The small streams coming out of the mountain, the so-called tributaries, and water flowing from the heights, defined as high energy water, are feeding the wetland with water. The sites with high water energy are characterized by erosion like gullies, due to the high water velocity. Other waters do not have that high energy and therefore erosion is not found at those places. The yellow areas are showing bare sediment areas deposited by the river. The only back road is the one going to the farm of Pierre Oelofsen and the main road is located along the wetland. On the eastern border two structures are built, and on the western border just one. These structures are built with the purpose to stop erosion.

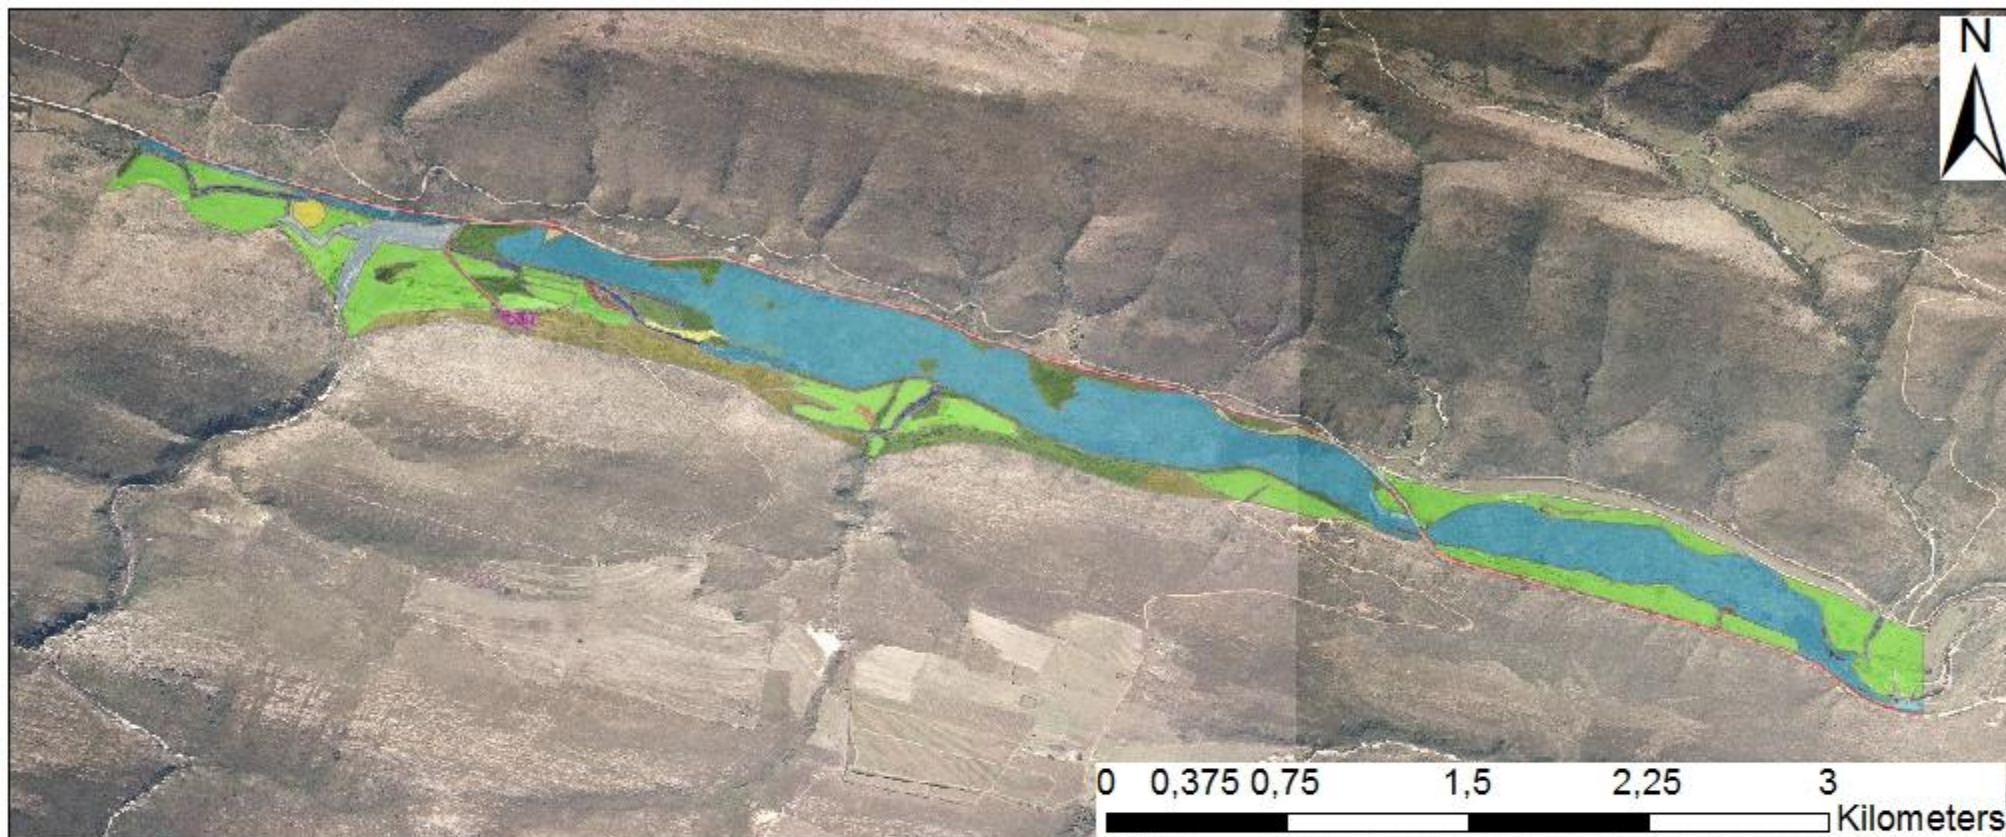
# Current vegetation cover project area

The project area is characterized by a lot of different fynbos species. The slopes are covered with a mix of fynbos species. The fynbos species Palmiet performs as an important plant in the wetland. This plant is accompanied by a mixture of bulrushes. Alien invasive plants like Black Wattle and Kikuyu are scattered around in the Upper Kromme Catchment. Figure 11 shows a global view of the wetland vegetation.

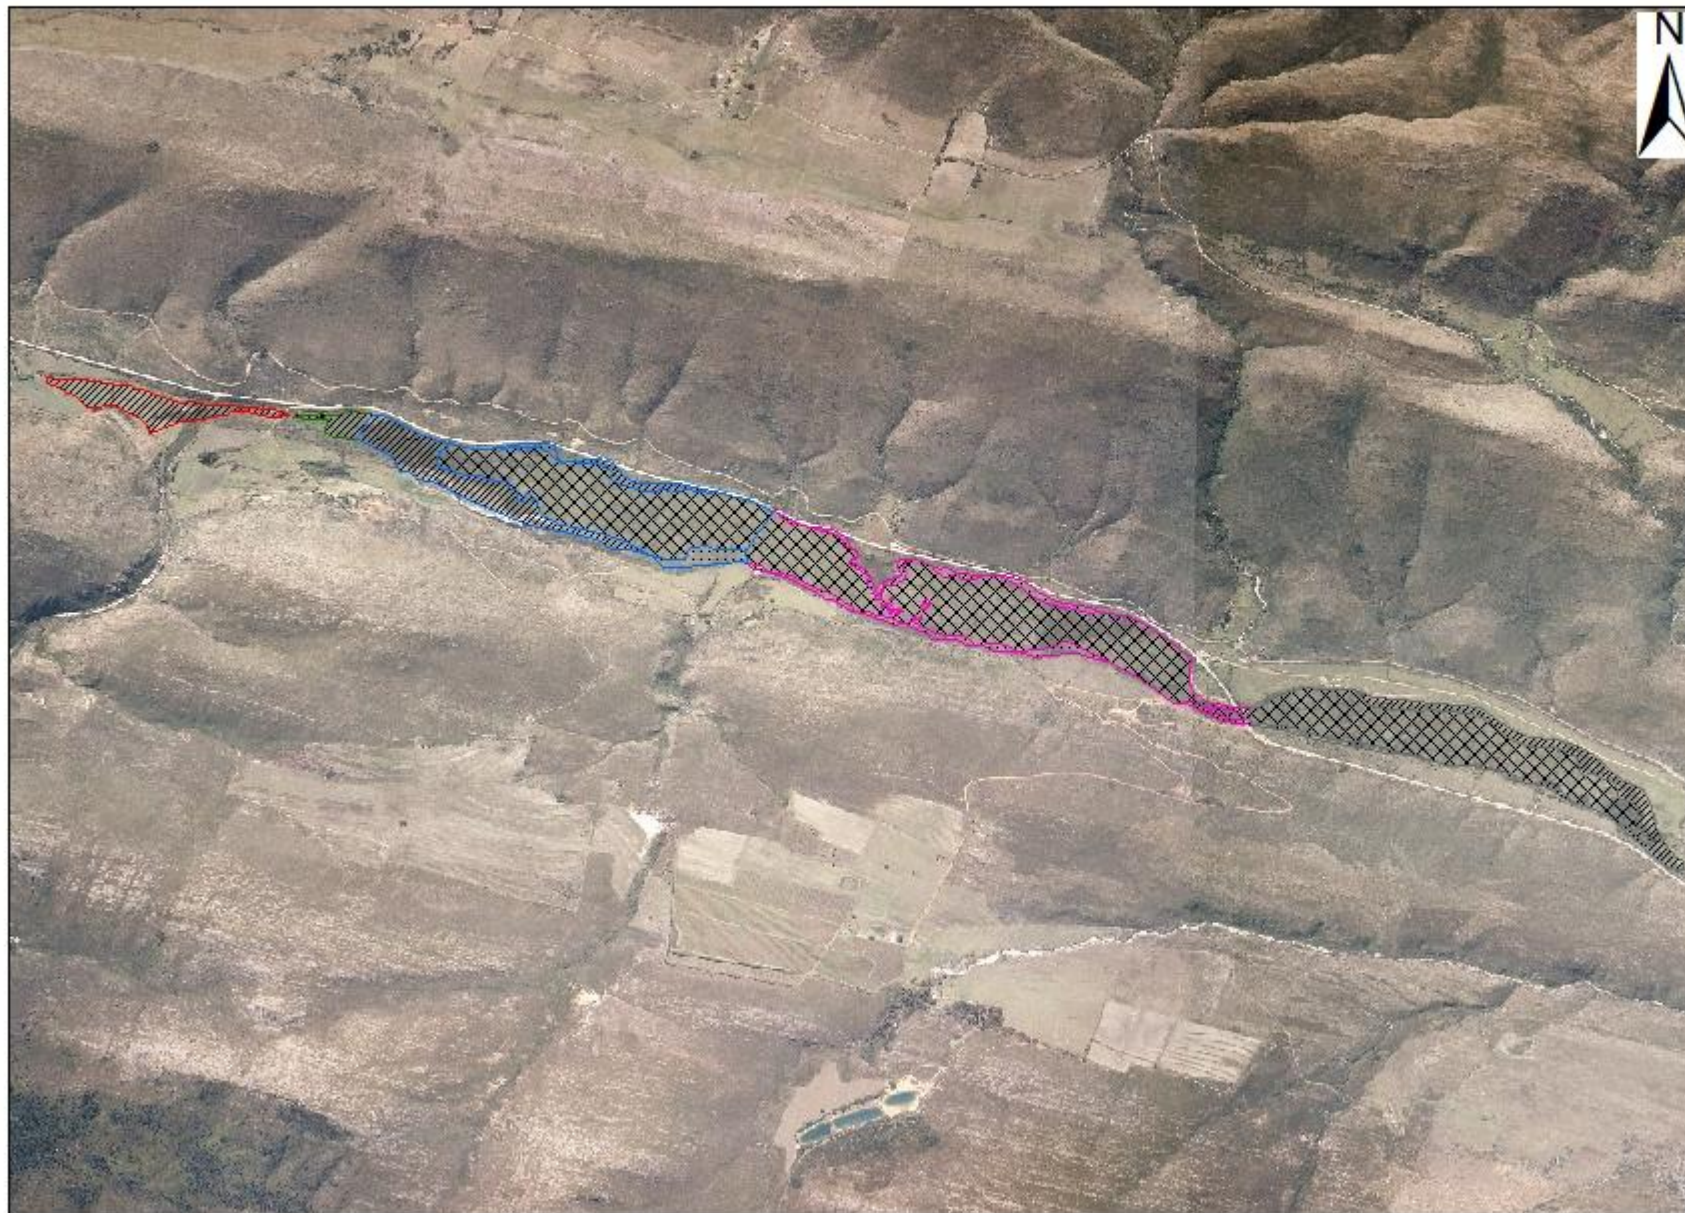
# Area peatbasin in 1942 and 1999

One of those protected wetlands is the Upper Peatland Basin, owned by Pierre Oelofsen and Dennis Ferreira. Despite this protection, the wetland is degrading at this moment. 19 % percent of this wetland has already disappeared between 1942 and 1999. In order to restore the Upper Peatland Basin, a proposal for rehabilitation and maintenance for this wetland is written down.

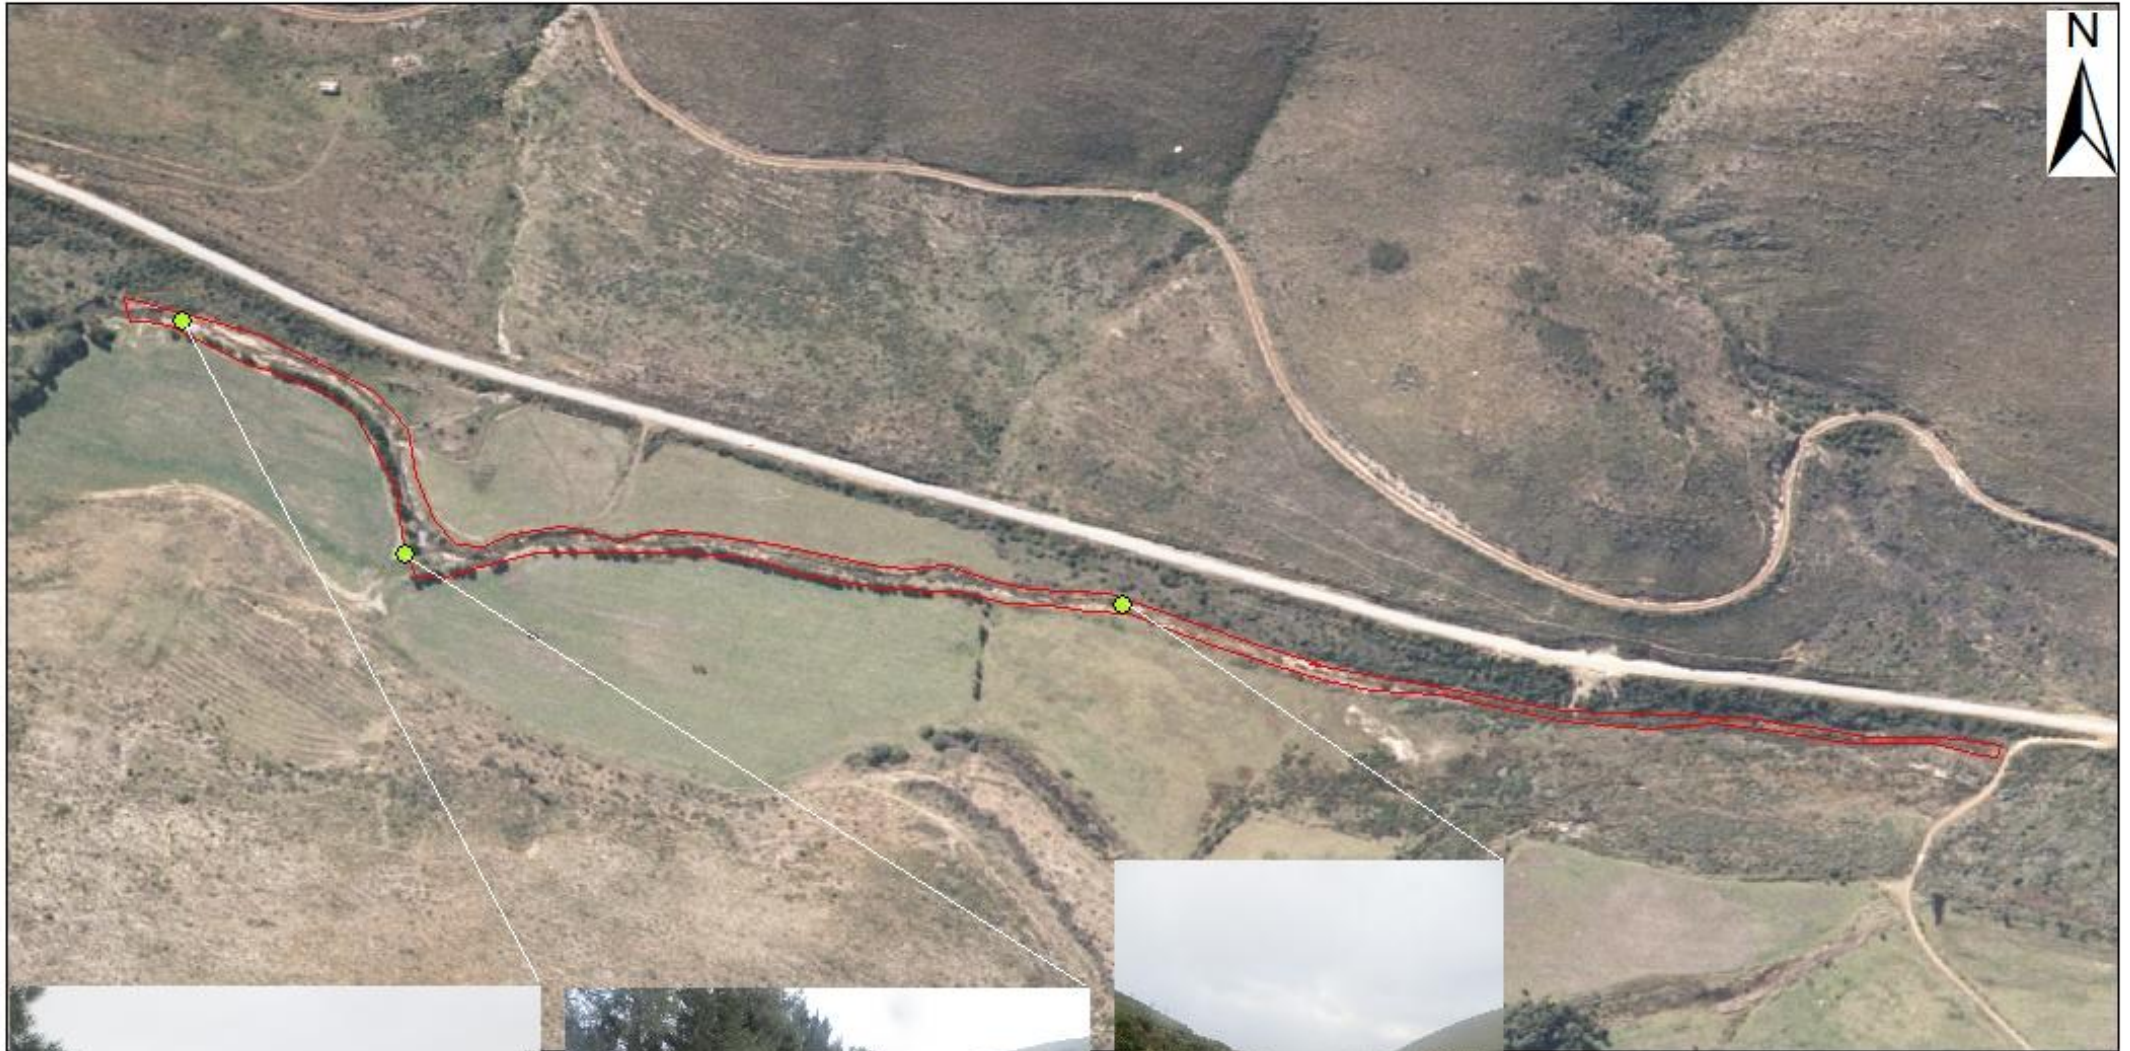
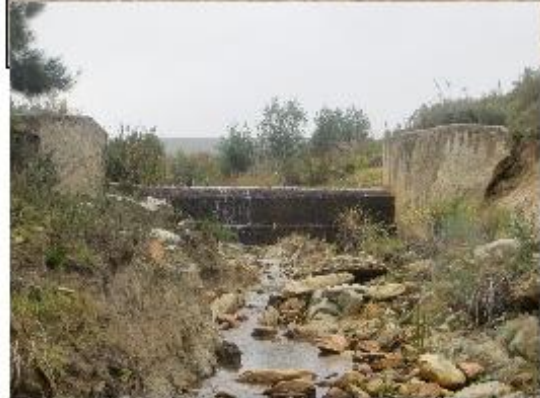
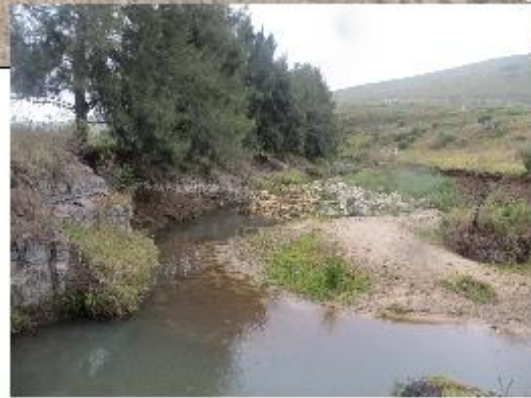
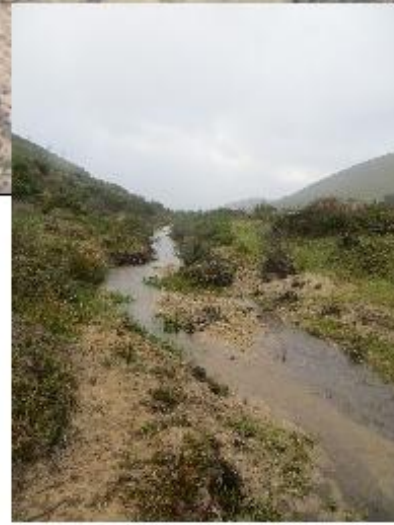
# Location gully 1

Gully 1

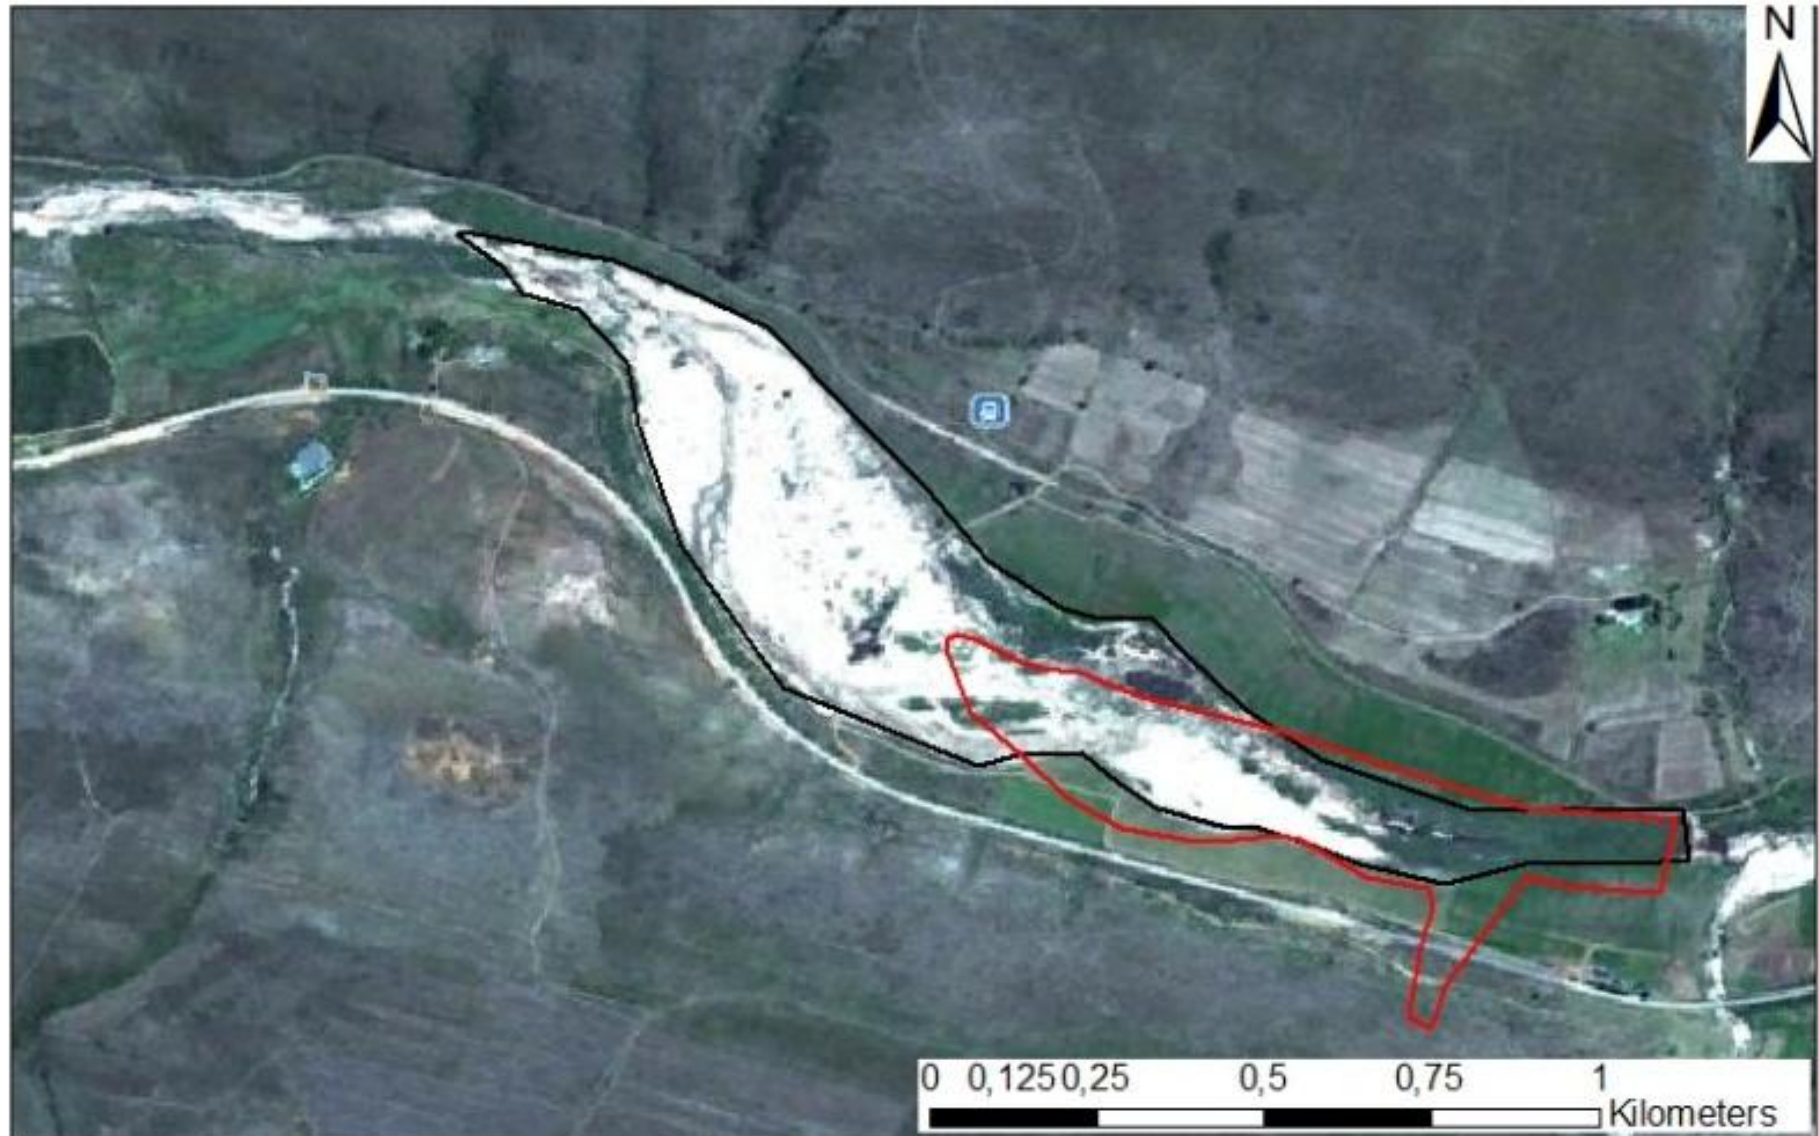
# Two potential new wetland areas as result of a gabion

Potential new wetland area in western part project area
