# Proposal for rehabilitation of the Upper Peatland Basin

Frederik Jansen and Jelle van Veen

Land and Water management

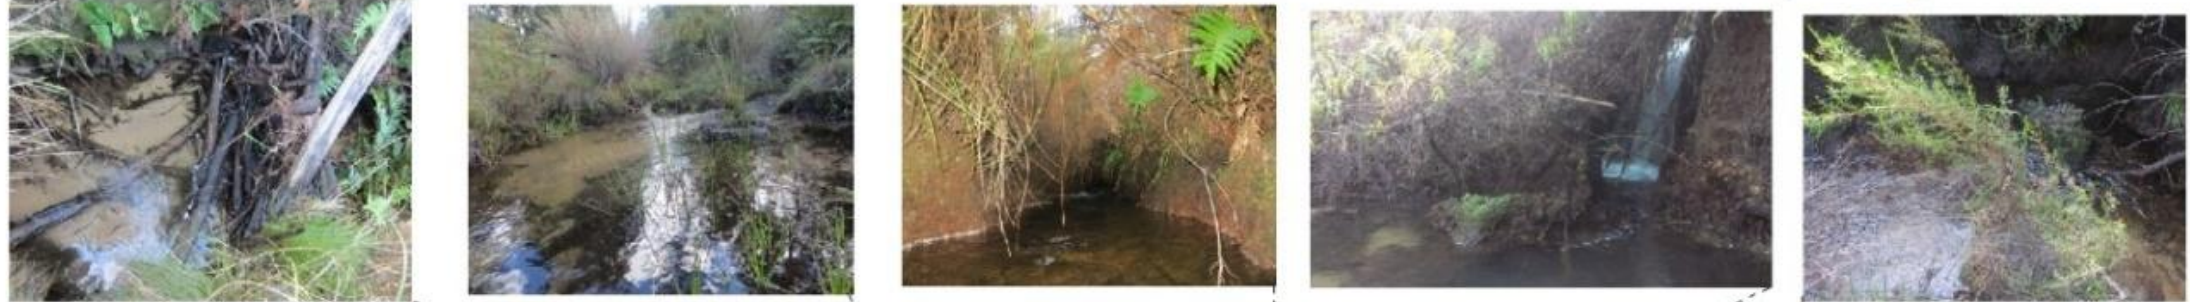
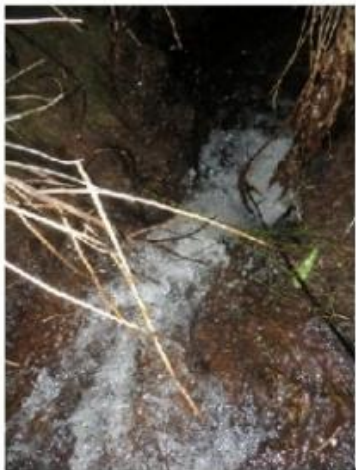
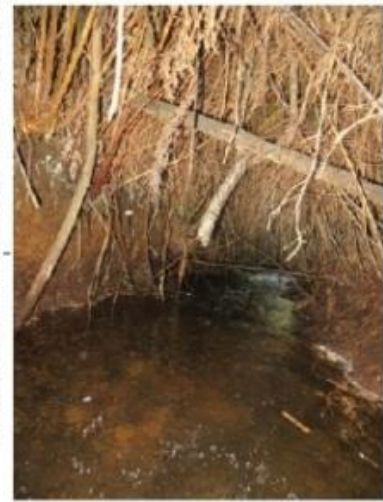
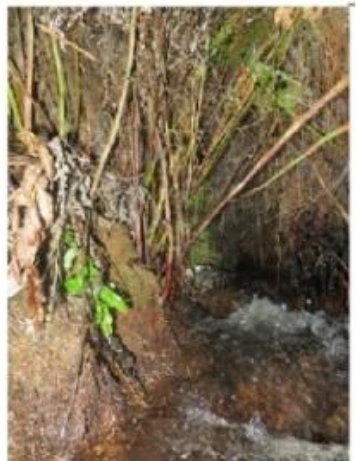
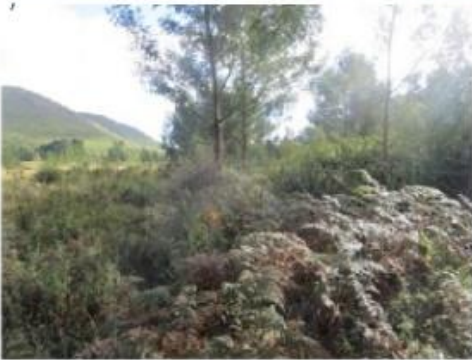
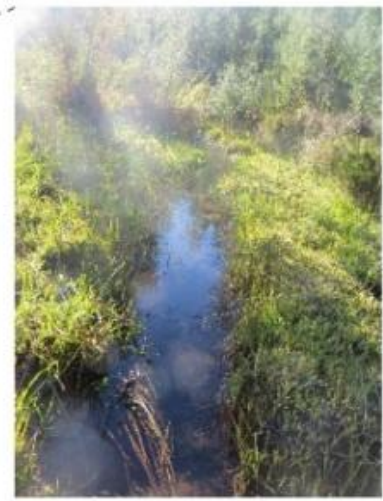
# Location drains and depth main drain (cm)

- Headcut main drain
- Measure points main drain
- Berm
- Drain

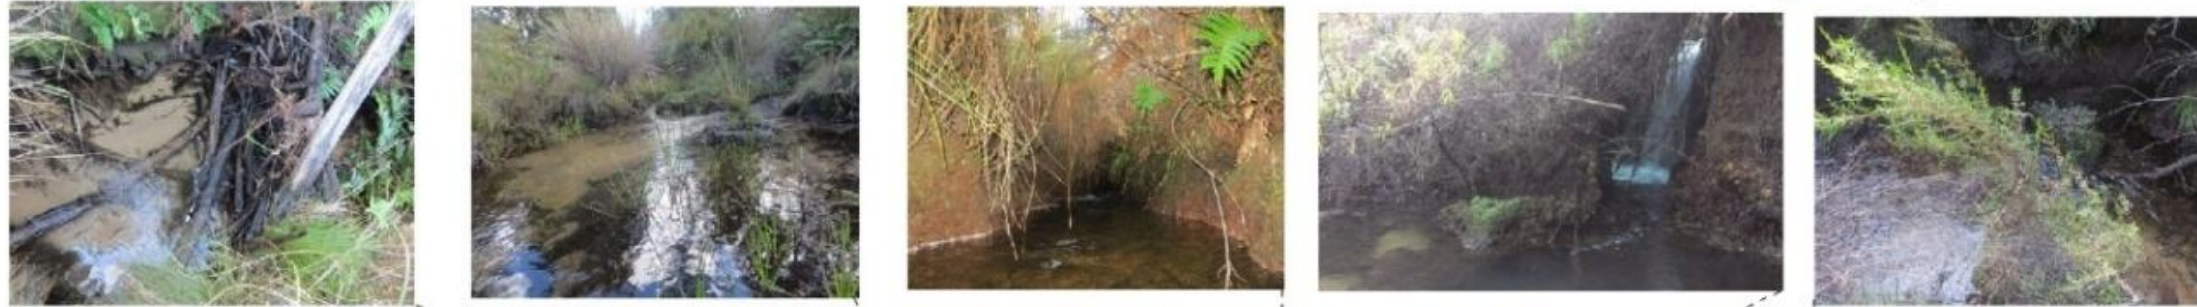
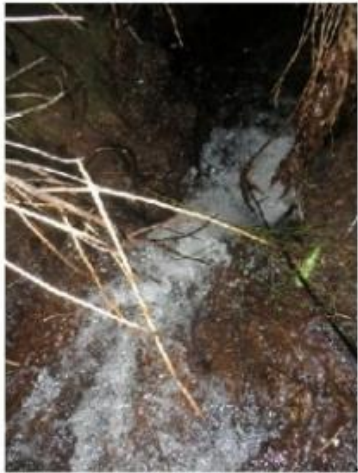
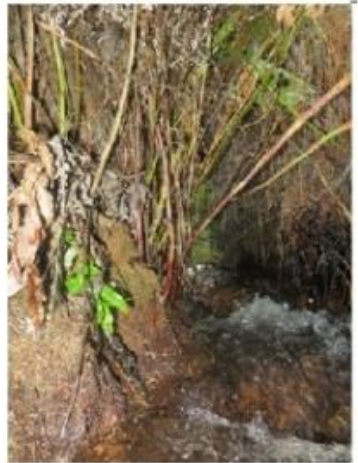
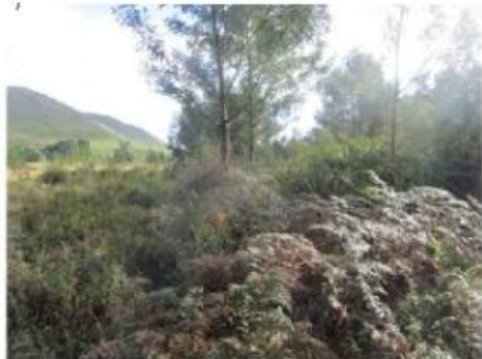
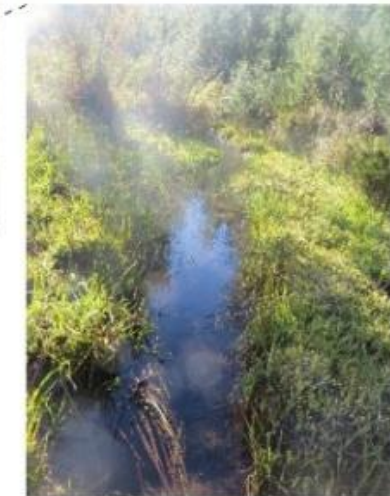
# Location drains and width main drain (cm)

- Headcut main drain
- Measure points main drain
- Berm
- Drain
