Deliverable No. 5: Project K5/2338/1

Progress Report 4: River reaches 2nd year quantifications & development of transmission loss parameters

Quantification of transmission processes along the Letaba River for improved delivery of environmental water requirements (Ecological Reserve)

Feb 2016

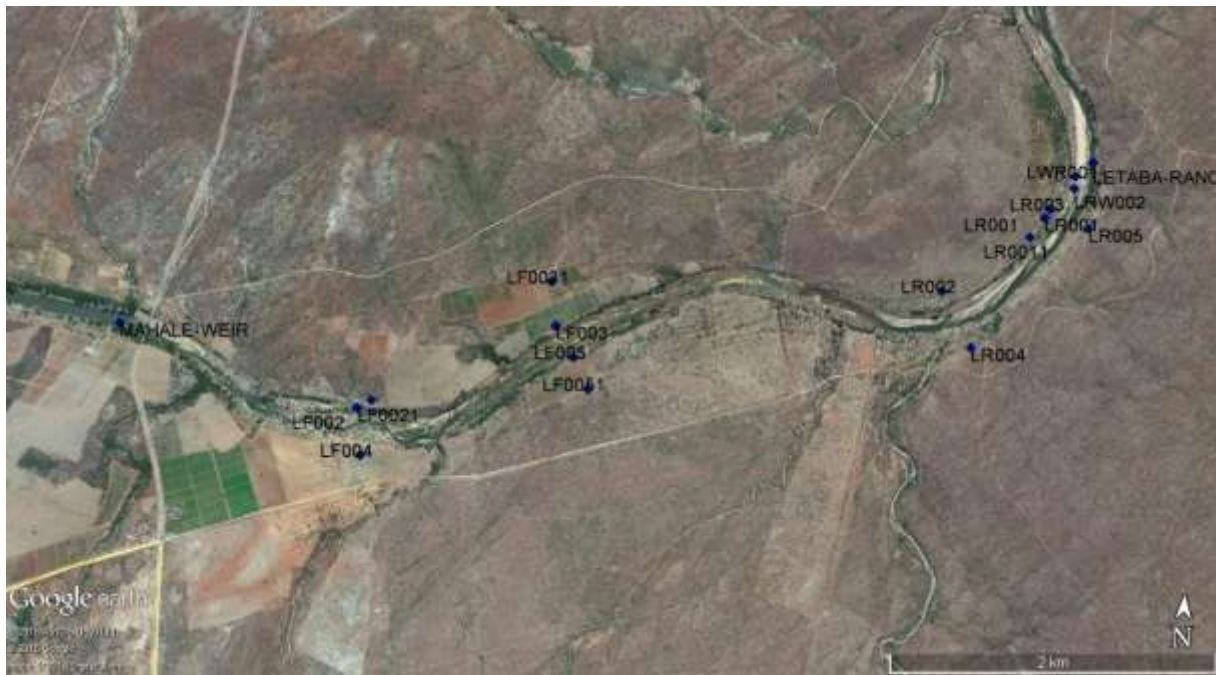
Figure 2-1: Groundwater peizometric monitoring network at the Letaba river Transmission Losses study site as of February 2016.

The following section highlights main observations during fluid logging of the drilled boreholes at the Letaba study site using a YSI 600 XLM multi-parameter probe (for locations see Figure 2-1).

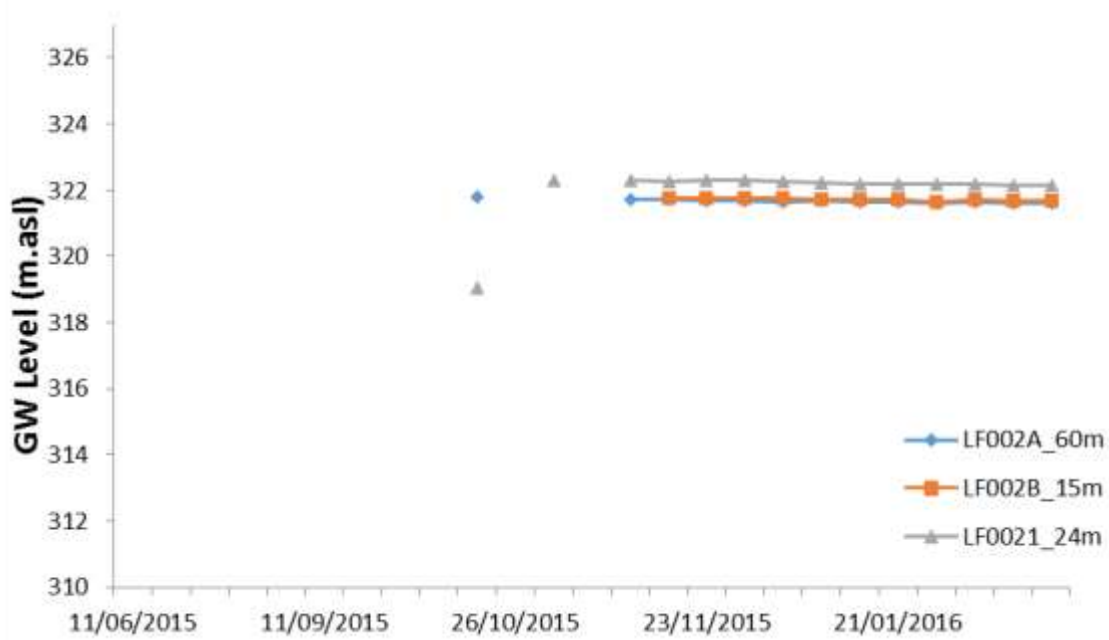
Figure 3-2 Water level responses at LF002

Boreholes LF002A/B are located within the farm area of the study location. LF0021 is located just west of LF002 within a suspected paleo-floodplain. The manual water levels (Figure 3-2) depict a relatively steady decline over the summer season during which very little to no recharge occurred. The greatest drop in hydraulic head between these 3 boreholes were found in LF0021 with a drop of 0.14m. LF002A and LF002B decreased by 0.086m and 0.1m respectively and indicating a greater drop in hydraulic head in the shallower borehole. LF0021 displays a higher water level than LR002A/B however they all decline at a similar rate indicating that the aquifer connectivity in this vicinity.

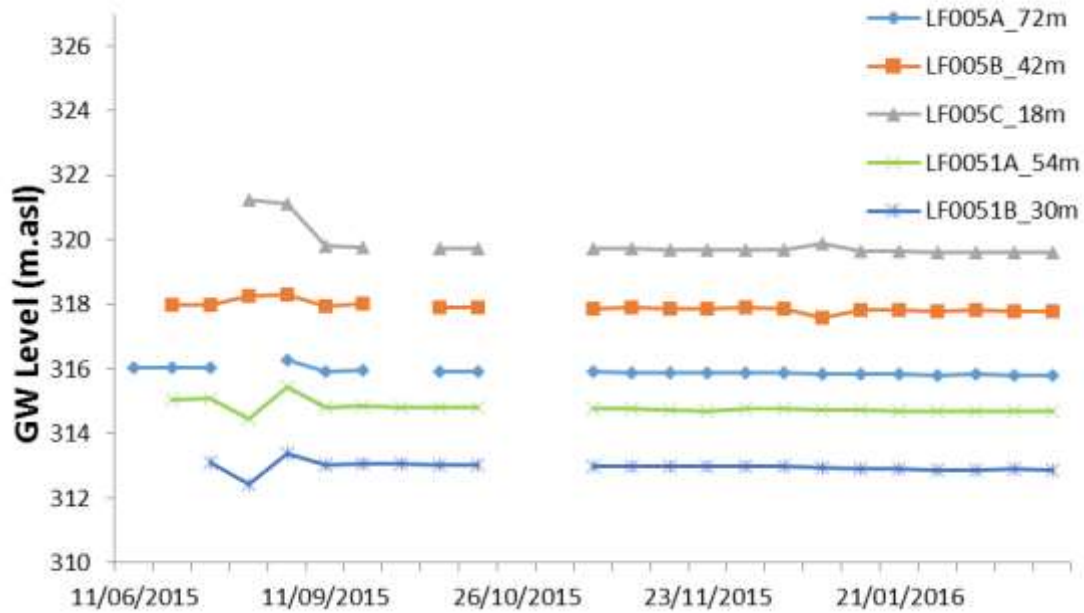
Figure 3-5 Water level responses at LF005 and LF0051

LF005A/B and LF005A/B/C is located on the southern bank of the Letaba River opposite LF003A/B. These boreholes display the longest range of data as they were drilled first. A steady decline is observed in all the boreholes with an average decrease of 0.15m indicative of them sharing the same aquifer. A definitive hydraulic gradient is observed from LF005C to LF005B. When taking LF003 and LF0031 into consideration it is apparent that the groundwater flow direction is from north to south in this transect. LF005 and LF0051 shows a small decrease in water levels when compared to LF003/31 indicating that the river might be contributing by flow losses to the groundwater aquifer in the southern bank.

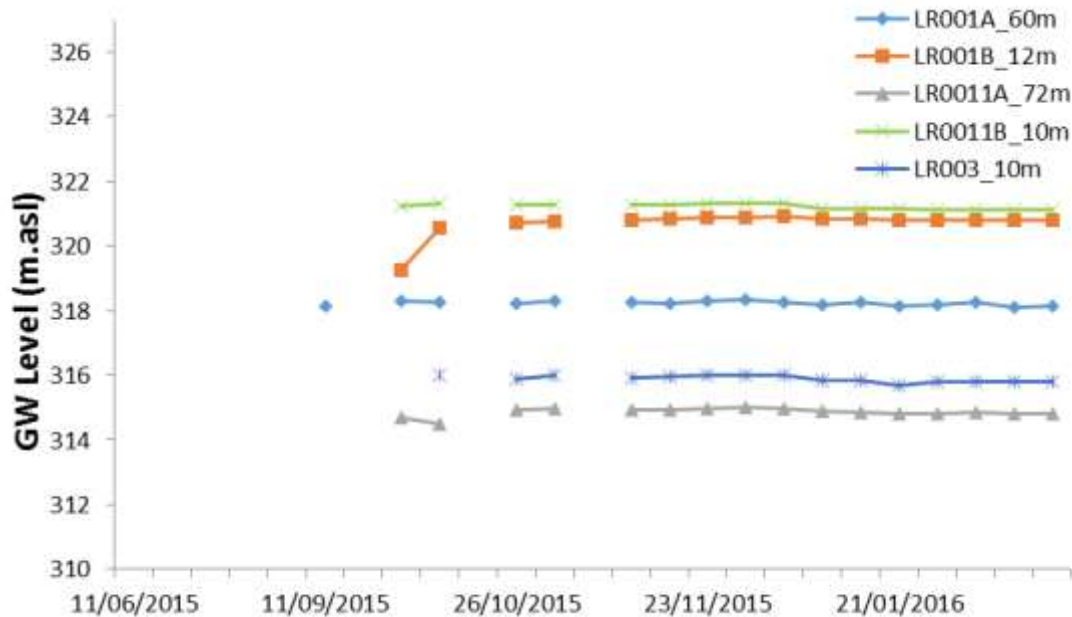
Figure 3-6 Water level responses at LR001, LR0011 and LR003

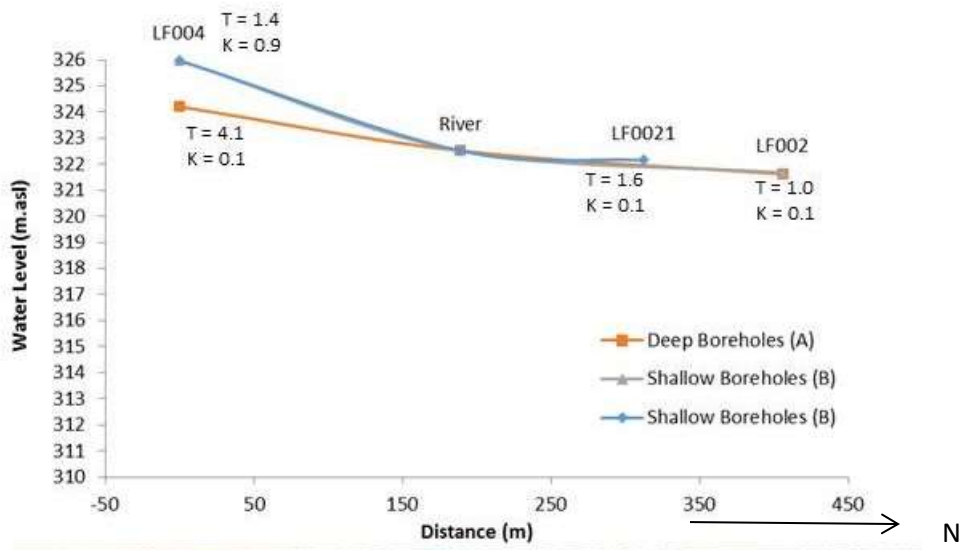
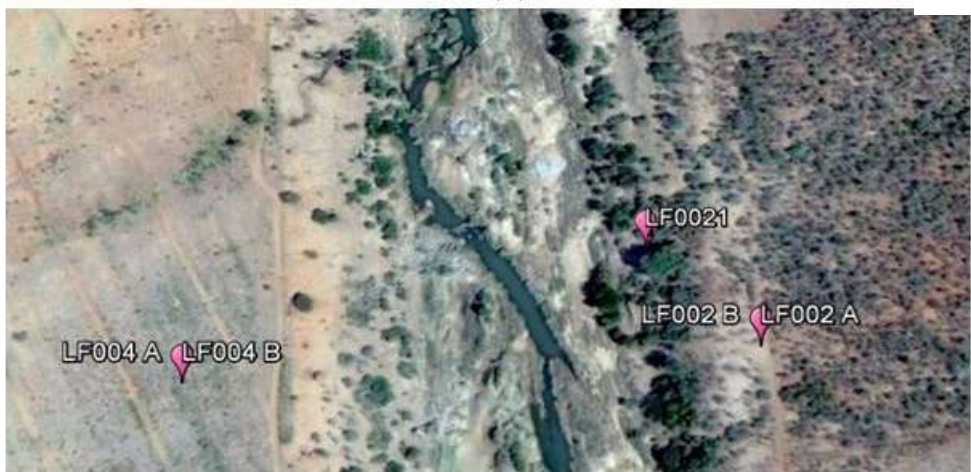
Figure 3-9 Cross-section plot of transect LF004 to LF002, February 2016

Commencing with Figure 3-9 for the most upstream transect, the hydraulic gradient shows potential groundwater flow from south (LF004) to north (LF002). The T values show that there is a higher flow from the southern bank to the river especially from the deep hard rock aquifer. After intersecting with the river the T values display a slight loss to the river but, a greater loss to the riparian zone as indicated by LF0021. The shallow boreholes show a much larger decrease to the north possibly from river drainage to the aquifer and possible losses to riparian vegetation transpiration.

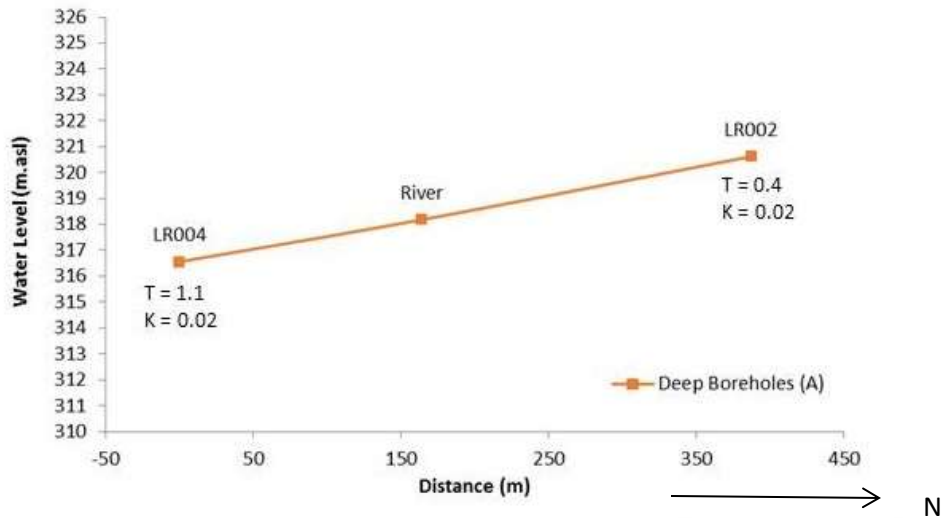
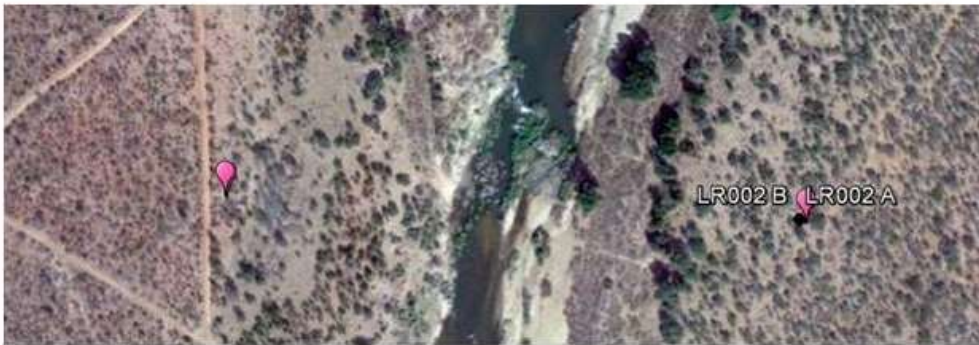
Figure 3-11 Cross-section plot of transect LR004 to LR002, February 2016

In **Figure 3-11** it appears that the groundwater flows from the northern bank to the southern bank. The deep hard rock aquifer does not appear to be largely affected by the intersection of the river. The T value of LR002 display a small gain to the river from the surrounding aquifer while the T value of LR004 shows a potentially large gain to the aquifer from river losses.

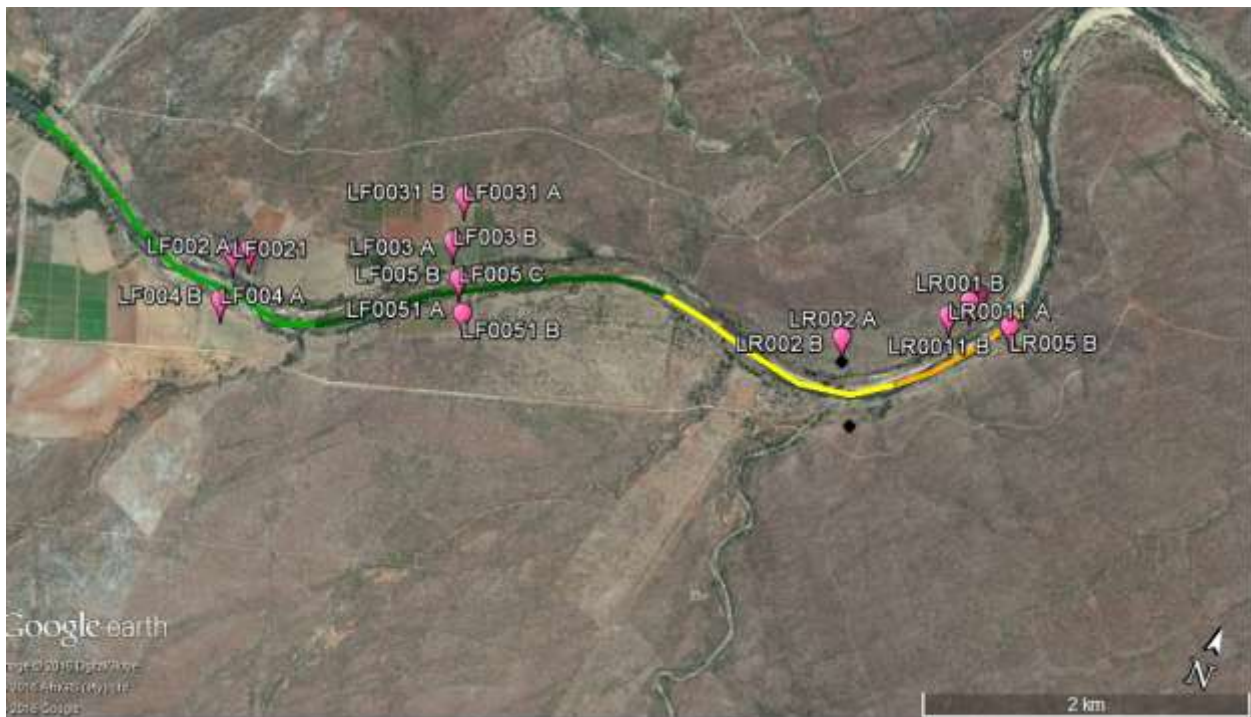
Figure 4-1 Assumed river reaches between Mahale and Letaba Ranch weirs associated with geohydrological transects (green represents farming areas and yellow the protected areas).

In accordance with the 4 geohydrological transects described an estimate was made of the approximate river reach lengths represented by the surrounding aquifers, as depicted in Figure 4-1, which divides the river between Mahale and Letaba Ranch weirs into 4 representative river reaches upon which the interaction between the river and the aquifer can be estimated in terms of either gains or losses from the water course. These river reaches will be surveyed in detail over the next few months in order to accurately quantify representative river reaches.

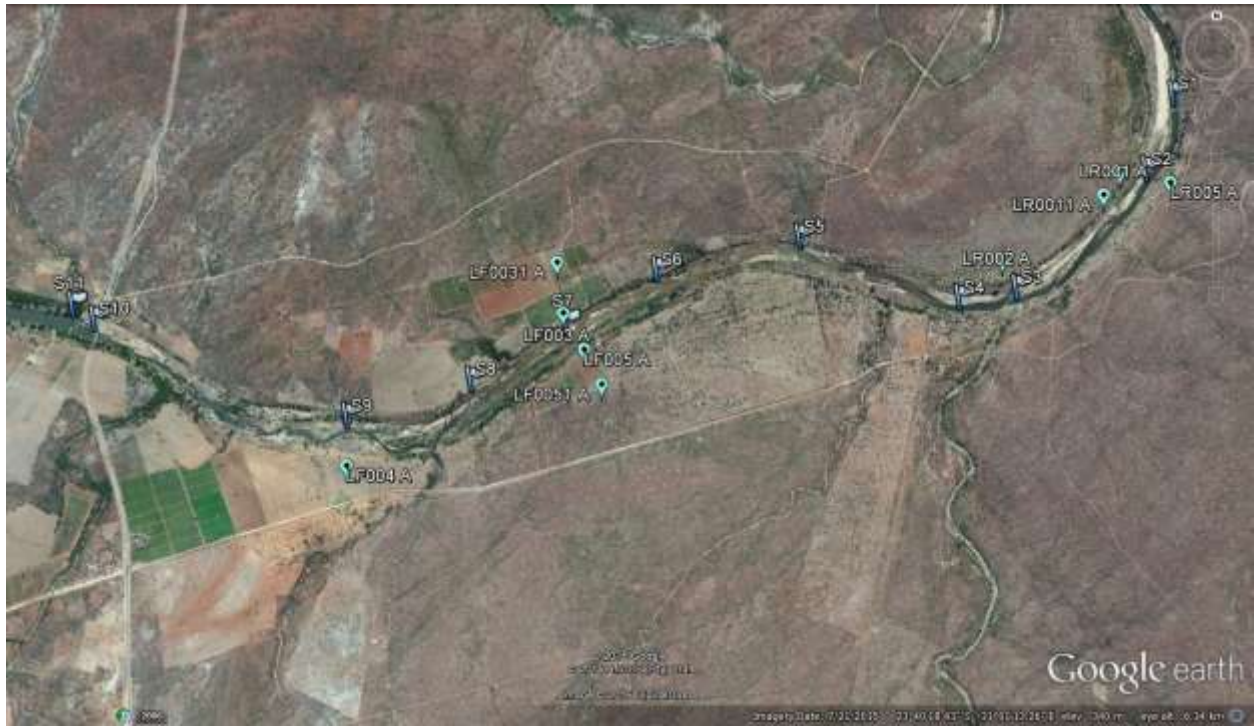
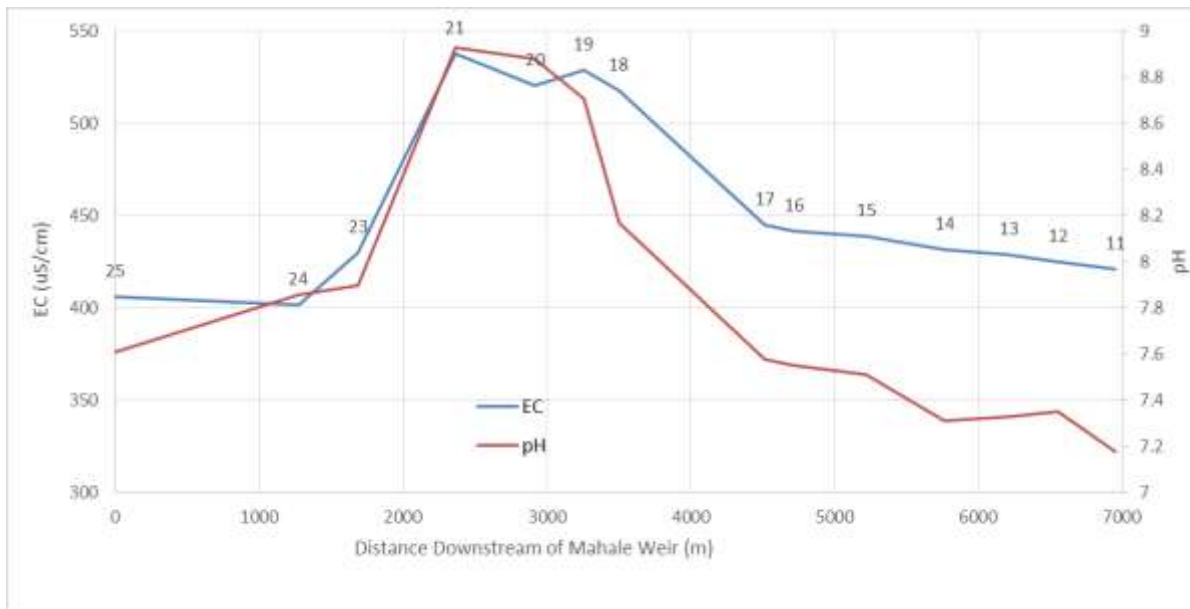
Figure 5-1 Results of longitudinal hydro-chemical snap-shot survey of the Letaba river between Mahale and Letaba Ranch on 24 November 2014 (above) using parameters measured in in-situ and 27 October 2015 by the MOSA Mobile Laboratory (below).

The previous sections have detailed the initial hydrometric results from the piezometric borehole network. Based on this and the first fluid logging results from the boreholes (Appendix I) as well as the two longitudinal hydrochemical profiles of the entire river reach (**Figure 5-1**) it is possible to present an updated conceptual model for the study site. This being from the groundwater-surface interactions perspective.

Figure 5-1 compares the survey of November 2014 which can be considered representative of the dry season, but following a wet cycle climatically. With the October 2015 survey also in the dry season it does follow a significantly below average rainfall year. This figure reveals two interesting aspects. The first being the apparently lower EC in the November 2014 survey, with a clear increase in EC in the river reach represented by the LF003-LF005 transect in the farming area, which then returns to a lower EC further downstream. This contrasts with the higher EC throughout in October 2015 with no EC elevation at the LF003-LF005 transect. Two factors may explain this: low flows in the Letaba river were significantly lower in the latter period ($<0.5 \text{ m}^3$ at Letaba Ranch) compared to the former ($\sim 1.0 \text{ m}^3$ at Letaba Ranch) and therefore subject to greater concentration of salts from natural processes as well as anthropogenic activities; whilst the 2014-15 being a low rainfall year may have prevented a significant hydraulic gradient from the weathered zone and disturbed landscapes of the farming region on the northern bank of the river (LF003-LF0031). This is of course speculative as we have no groundwater observations to verify for this period, but certainly an aspect to consider in long term monitoring of the site.

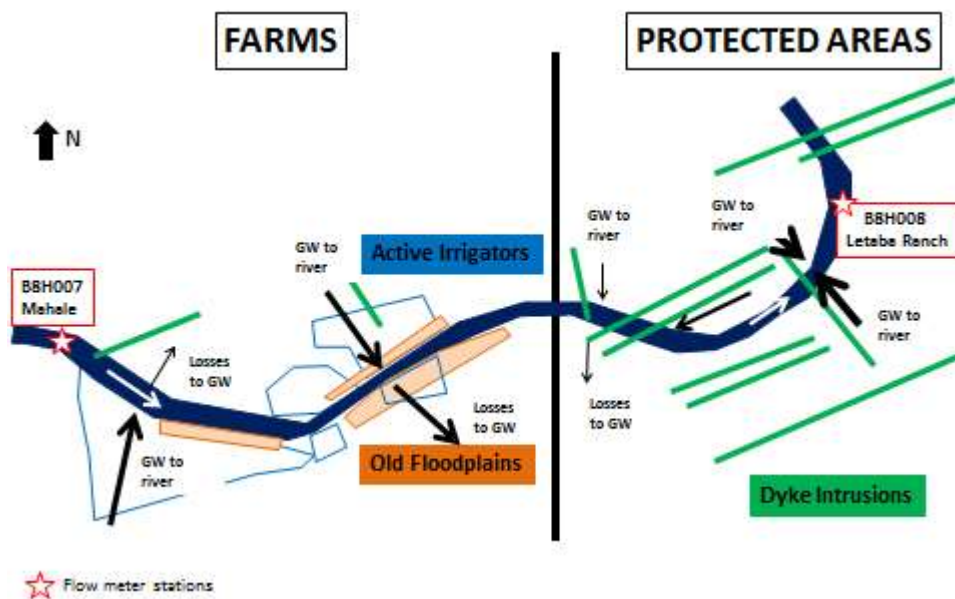
Figure 5-2 Updated geohydrological conceptual model of the study site

The initial interpretations outlined allows for an updated conceptualisation for the study site as revealed in Figure 5-2. In summary therefore one expects moving forward in this study to see greater evidence for groundwater accruals to the river from the south in the eastern farming area, with some losses from the river channel on the northern bank. Whilst moving west but still within the farms, the river may appear to intersect the regional groundwater flow path, and it is expected that paleo-floodplain alluvium is the conduit for an unconfined aquifer in this region. Moving downstream one sees significant inflows from the regional aquifer on both sides of the river.

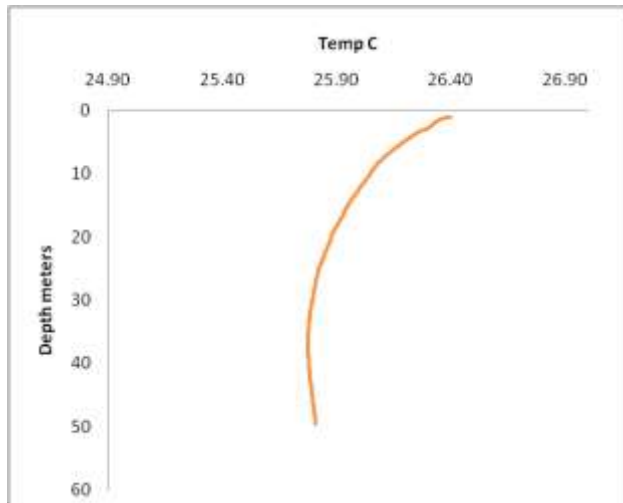
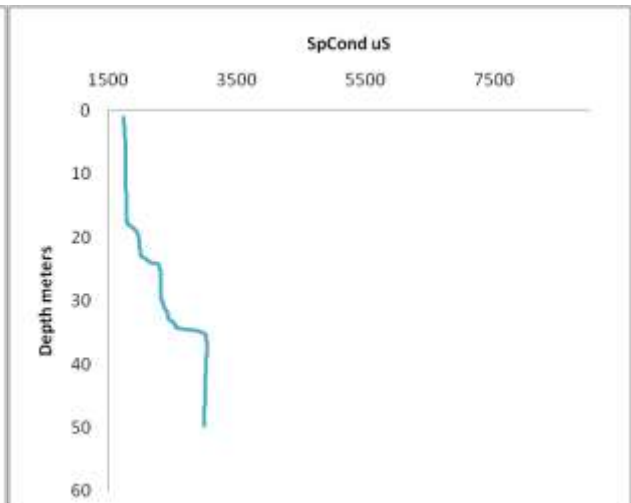
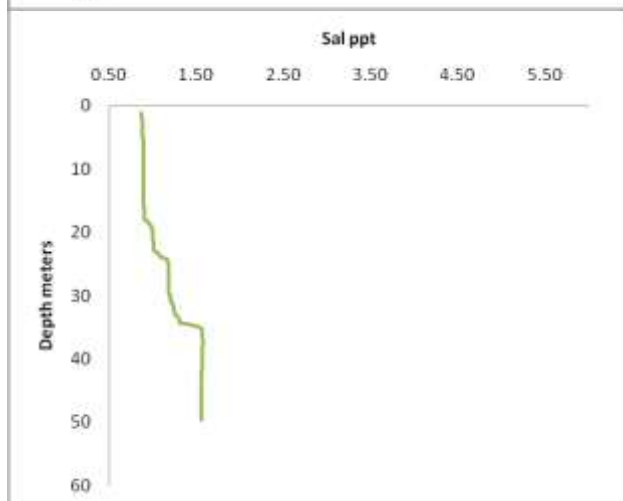
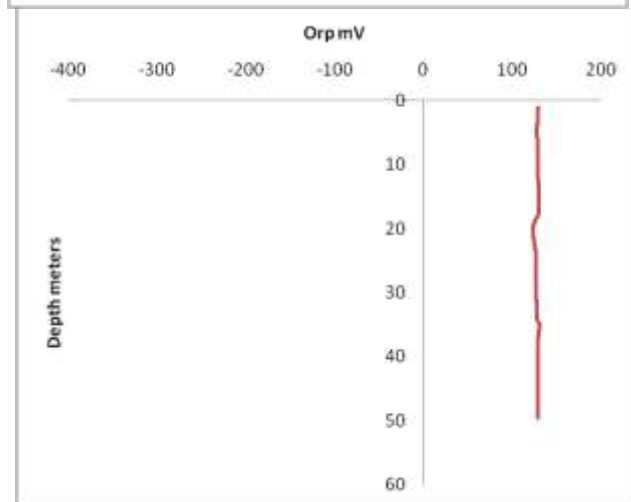
LF002A - The temperature here decreases with depth until it reaches 35m, where it starts to increase again. This is a result of the inflow of water through a possible fracture that decreases the temperature above and below the fracture, thus the closer the water in the borehole is to the fracture the colder the water will be. This phenomenon can be seen in most of the boreholes that were tested. The salinity and conductivity confirms the temperature phenomenon showing a sudden increase as soon as the fracture is passed at around 35m and also at 22m. Most of the boreholes show an increase in salinity and conductivity to the bottom of the borehole. This is due to the fact that the bottom contains lots of dissolved solids from debris falling from the sides of the borehole to the bottom. The possible fractures at 22m and 35m are also confirmed by the ORP (Oxidation-Reduction Potential) that indicates changes at these depths. The pH also indicates a quick rise in alkalinity as soon as it passes the 22m and 35m, indicative of inflow of increasingly alkaline ground water at those depths.

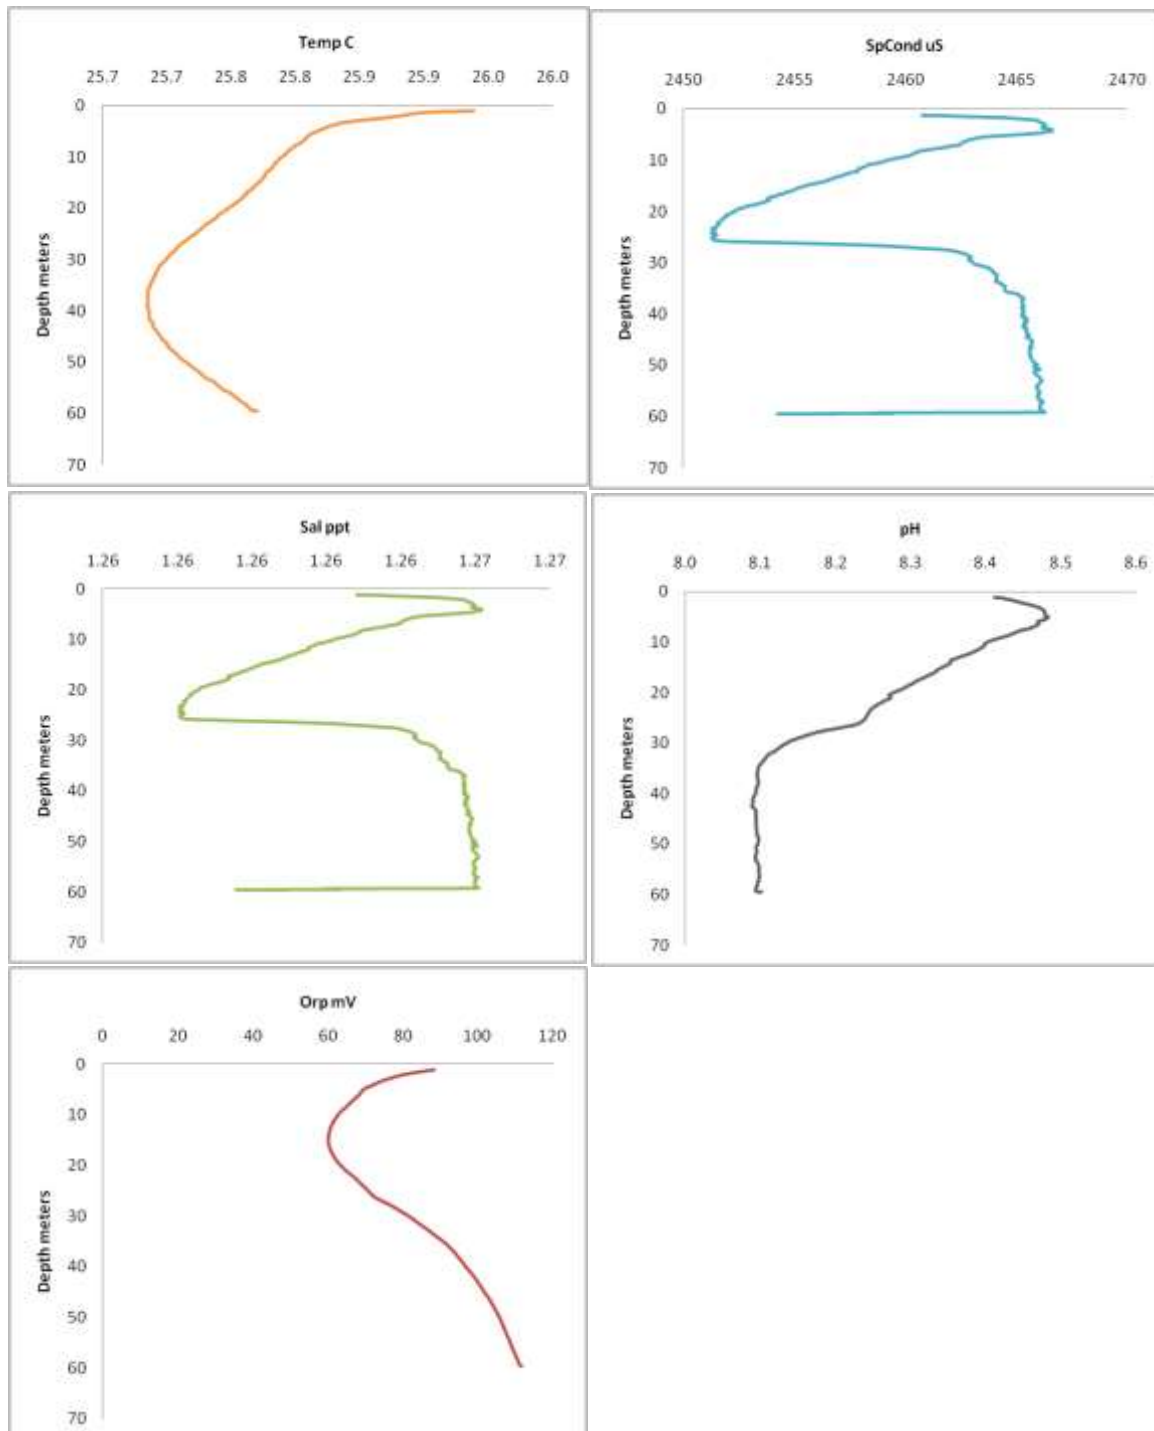
LF003A - The parameters at this location show two anomalies. The first is a rapid drop in temperature to about 5m after which there is a temperature decrease at a slower rate to the second anomaly located around 24m. The conductivity and salinity displays a similar trend with a quick increase to about 5m deep after which there is a sudden drop. This indicates the sudden inflow of groundwater through a fracture. This drop continues steadily to 21m where it stabilizes for 4m after which it drops quickly as it should to the bottom of the borehole that is high in dissolved solids. The stabilizing and quick drop of these parameters indicates a fracture at around 24m. The pH confirms the findings of the other parameters with a sudden decrease in pH at 5m after which it also continues to decrease to around 24m. From 24m to 32m it decreases slower and ultimately stabilizes. This decreasing of pH indicates the inflow of a slightly more acidic groundwater from the surrounding aquifer.

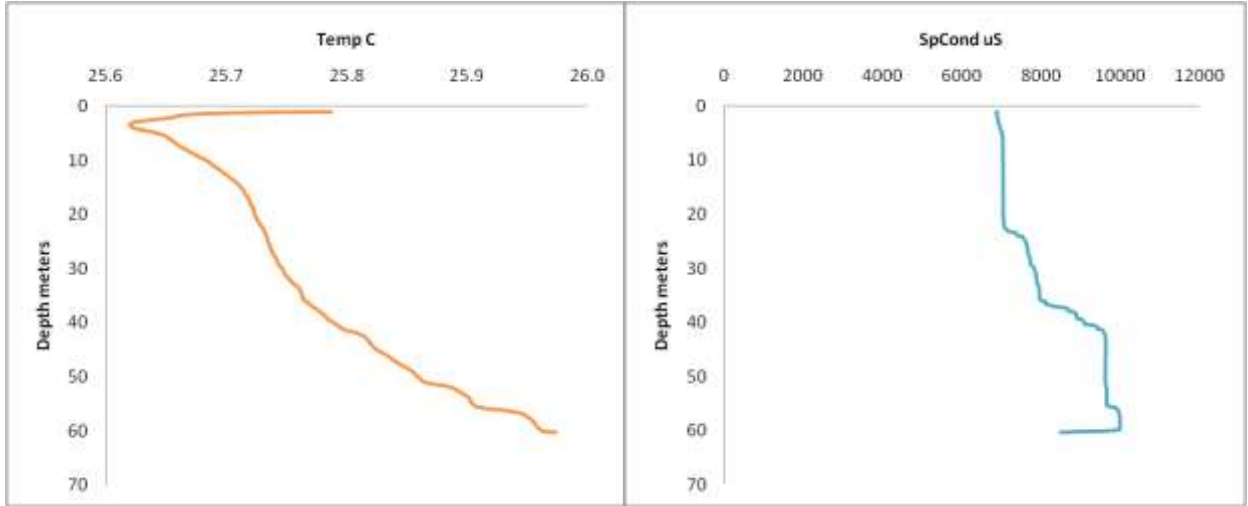
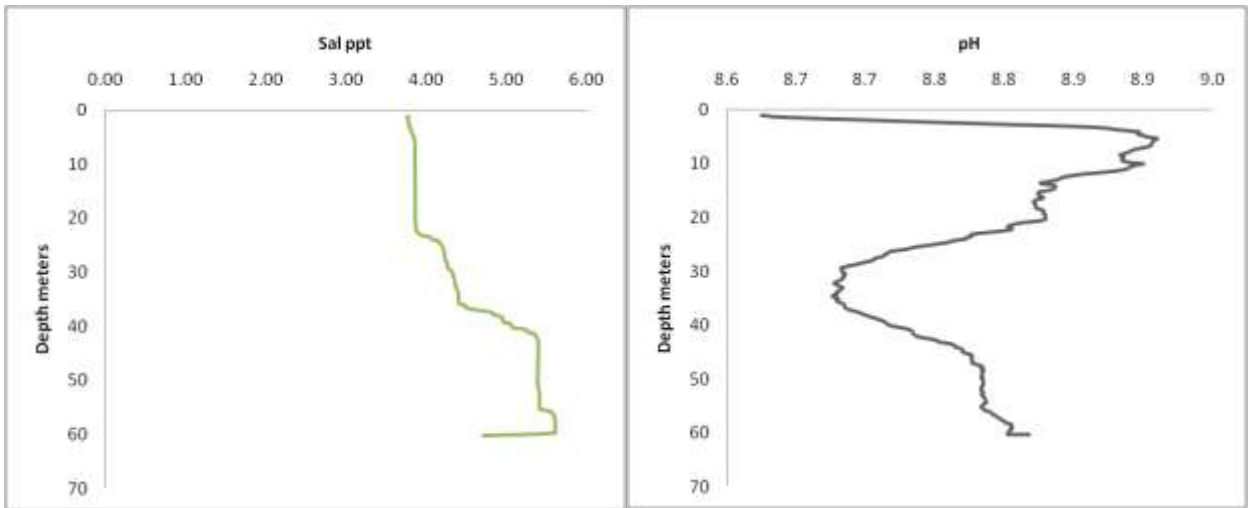
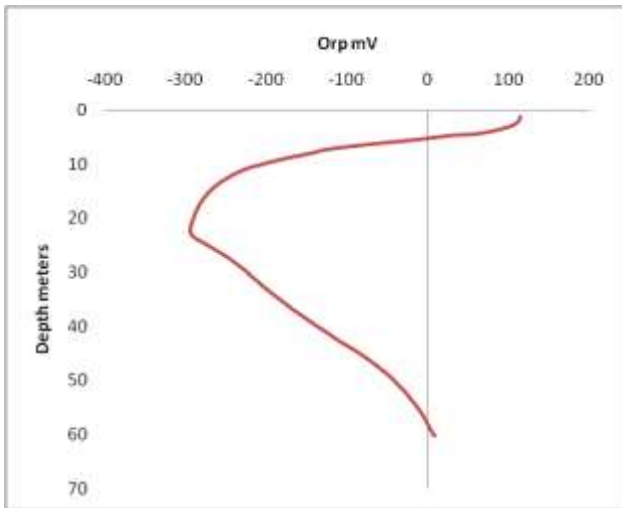
LF004A - The temperature does not follow the typical decrease and increase of the other boreholes. It only displays a steady decrease with no obvious anomalies. The conductivity and salinity in contrast show two anomalies with a sudden increase in these parameters at 20m and 33m respectively. The pH confirms this with a typical decrease at these two depths indicating an inflow of a slightly more acidic groundwater.

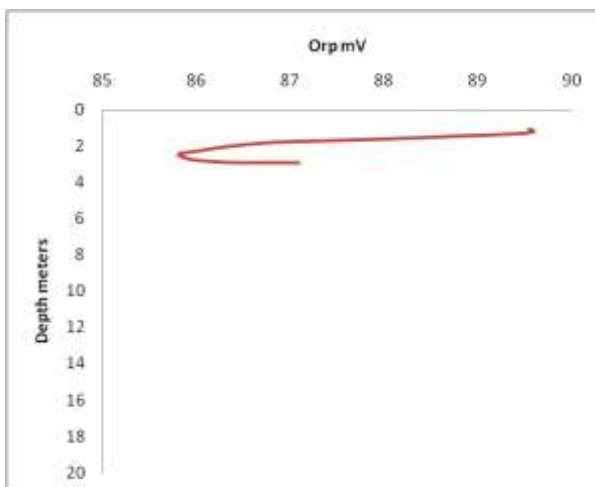
LF004B - All the parameters indicate an anomaly at 2.7m. The temperature indicates a small decrease almost at the bottom of the borehole. The conductivity and salinity also displays a sharp decreasing spike at 2.7m that is indicative of a groundwater inflow through a fracture. The pH and ORP confirms this with the pH indicating a sharp decrease from the inflow of a slightly more acidic groundwater.

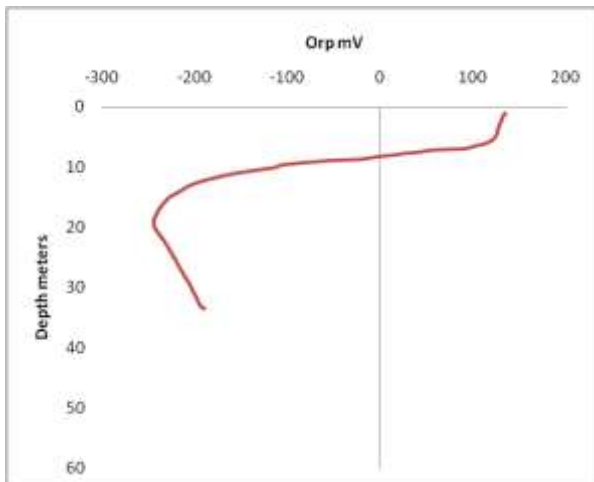
LR002A - The temperature follows the normal decreasing trend with no obvious anomalies. The conductivity and salinity also follows the normal trend until it reaches 20m and stabilizes. The pH and ORP show a possible small fracture at 20m with a decrease and increase respectively thus, confirming a small fracture at 20m.

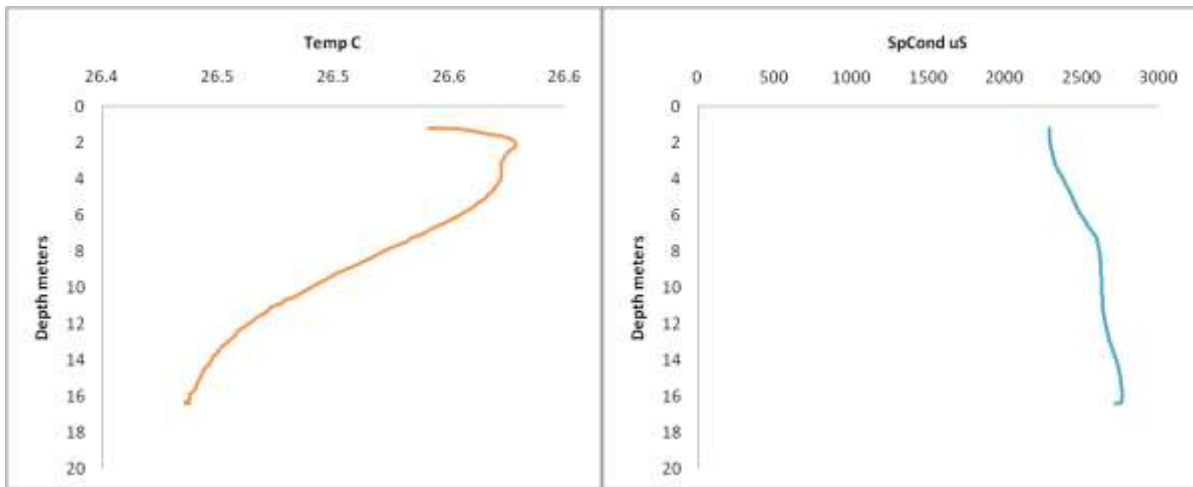
LR005B - this follows the decrease trend similar to LR005A but, the rest of the parameters display no obvious signs of a fracture.

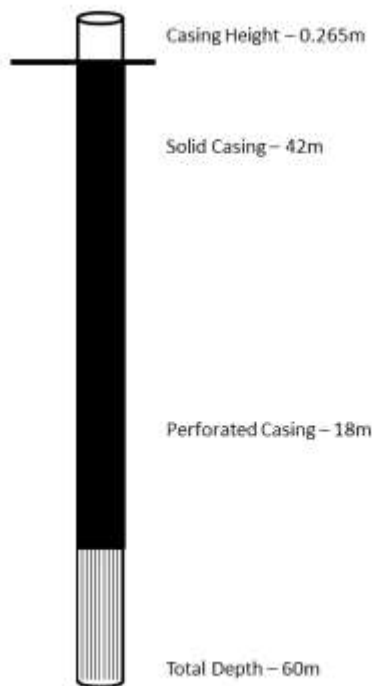
BOREHOLE NAME: LR005A

Date Completed:	09/07/2015
GPS Co-ordinates:	S 23.662268314° E 31.049551881°
Site:	Letaba Ranch
Borehole Depth:	60m
Water Strike:	25/38/50
Estimated Yield:	5.7 l/s

NOTES: This borehole is too deep and drilled beyond the unconsolidated material, therefore a shallower 24m borehole was drilled alongside LR005A (13/07/2015).

LR005A - The temperature shows the normal decrease - increase trend with most of the water flowing between 10m and 20m. The conductivity and salinity shows surprisingly very little changes. The pH on the other hand confirms a fracture at 10m with a decrease from the inflow of the slightly more acidic groundwater.

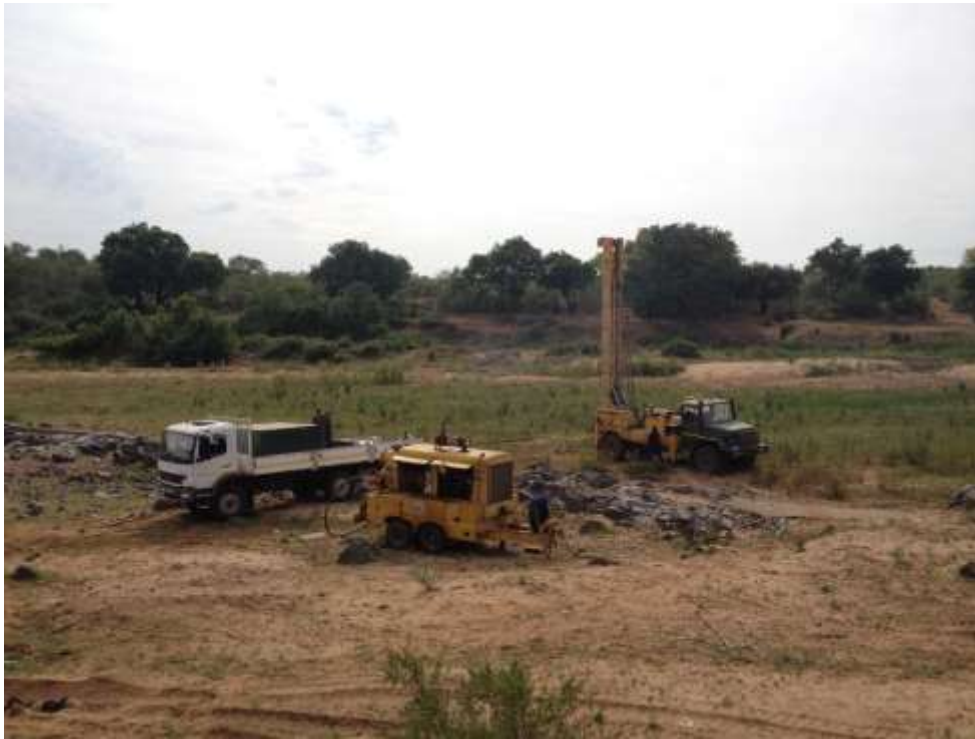
Figure III.1 Drilling river borehole (LRW002) in river bed close to Letaba Ranch gauge

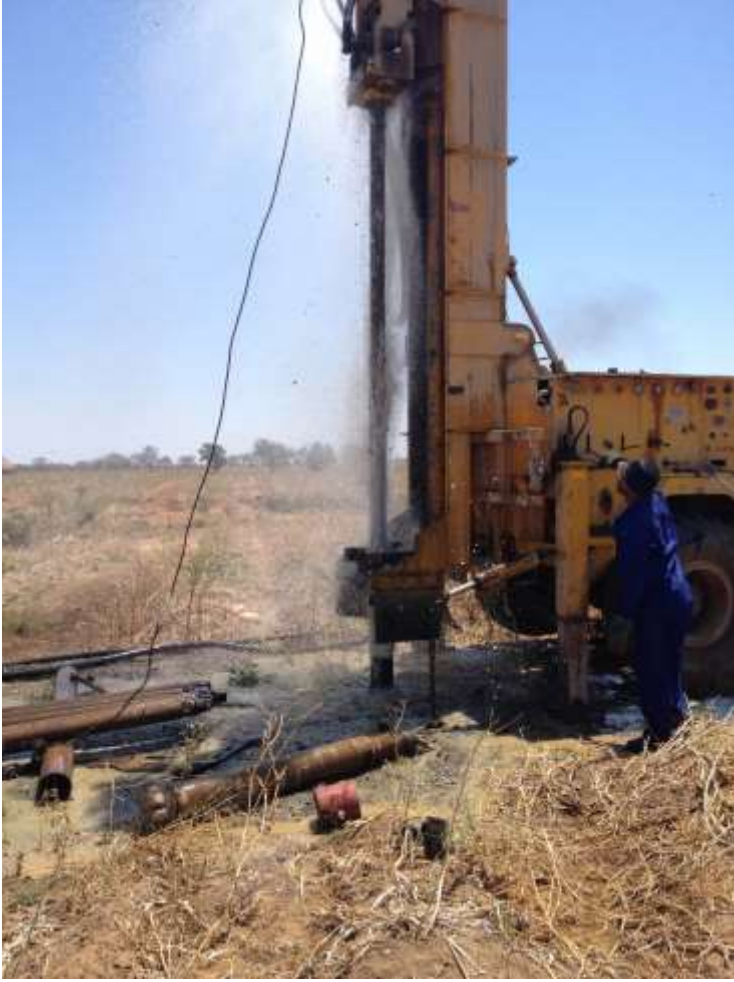
Figure III.2 example of the percussion drill during water strike
